# Access Compliance Report

## Public Rights-of-Way

### (Curb Ramps)

Intersection ID: 10447	Main Street: SYLVANIA_AV	Cross Street: BANCROFT_ST	Location: SW
ADA ID: 108C27E83A0F	Ramp Type: PerpDiag	Initial Pass/Fail: Fail	Overall Compliance: No
Severity Score: 8.75			
Codes/Mitigation Info/Possible Solution		Field Measurements/Component Compliance

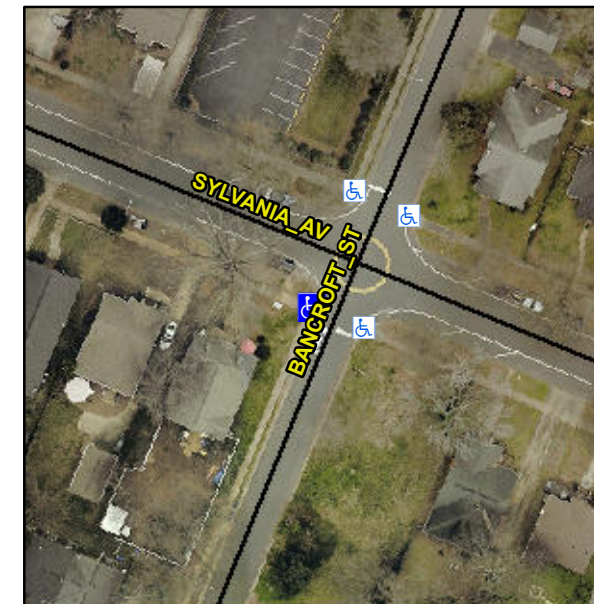
**Not Found, R304.5.1**

Compliance	Description	Data	Compliance	Description	Data
N/A	Ramp Length (in)	68.0	Yes	Ramp Slope (%)	6.5
No	Ramp Width (in)	37.0	Yes	Ramp XSlope (%)	0.6
N/A	Flare Type LT	N/A	N/A	Flare Type RT	N/A
N/A	Flare Slope LT (%)	N/A	N/A	Flare Slope RT (%)	N/A
N/A	Flare Traversable LT?	N/A	N/A	Flare Traversable RT?	N/A
N/A	Landing Length (in)	N/A	N/A	DWS Provided?	N/A
N/A	Landing Width (in)	N/A	N/A	DWS Contrast?	N/A
N/A	Landing Slope (%)	N/A	N/A	DWS Length (in)	N/A
N/A	Landing X Slope (%)	N/A	N/A	DWS Full Width?	N/A
N/A	Landing Curb? (Y/N)	N/A	N/A	DWS Offset (in)	N/A
N/A	Shared Landing?	N/A			
N/A	Gutter Ponding?	N/A	N/A	Gutter Slope (%)	N/A
N/A	Gutter Lip Ht (in)	0.75	N/A	Gutter X Slope (%)	N/A
N/A	Painted X Walk1?	No	N/A	Painted X Walk2?	No
	X Walk 1 Direction	To SE		X Walk 2 Direction	To NE
N/A	X Walk 1 Width (in)	N/A	N/A	X Walk 2 Width (in)	N/A
	X Walk 1 Slope (%)	2.3		X Walk 2 Slope (%)	1.7
	X Walk 1 X Slope (%)	4.8		X Walk 2 X Slope (%)	0.9

N/A	Ramp inside XWalk1?	N/A	N/A	Ramp inside XWalk2?	N/A
	Road Slope (%)	1.5	N/A	Clear Space?	N/A
	Road X Slope (%)	2.9	N/A	Clear Space to XWalk (in)	N/A
N/A	Any Obstructions?	N/A	N/A	Storm Grate/Utility Hazard?	N/A
	Obstruction Type			Storm Grate/Utility Type	
		N/A			N/A
			Yes	Surface Condition? (G/P)	Good

**Remove & Replace Curb Ramp With Two New Directional Ramps or Equivalent.**

Total Cost: \$ 3200.00
