Access Compliance Report

Public Rights-of-Way

(Curb Ramps)

Intersection ID: 50599	Main Street: HEARTLEAF_RD	Cross Street: STREAM_ORCHID_LN	Location: SE
ADA ID: 108F4D87A783	Ramp Type: Perp	Initial Pass/Fail: Fail	Overall Compliance: No
Severity Score: 22.5			
Codes/Mitigation Info/Possible Solution		Field Measurements/Component Compliance

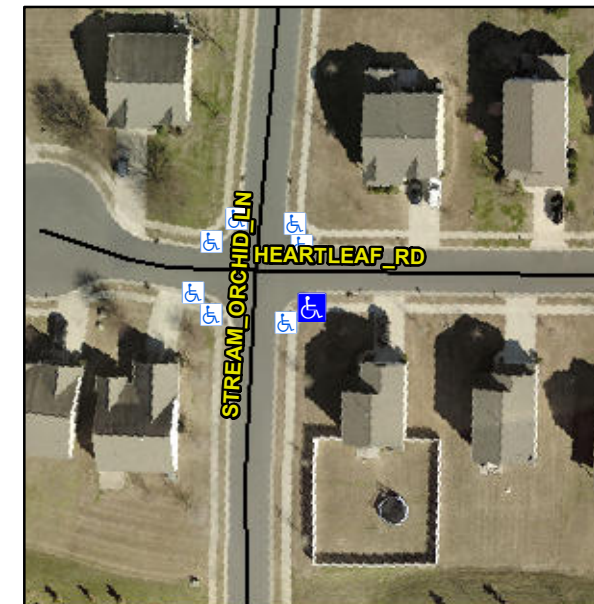
Compliance	Description	Data	Compliance	Description	Data
N/A	Ramp Length (in)	47.5	No	Ramp Slope (%)	8.4
No	Ramp Width (in)	47.5	No	Ramp XSlope (%)	3.6
N/A	Flare Type LT	N/A	N/A	Flare Type RT	N/A
N/A	Flare Slope LT (%)	N/A	N/A	Flare Slope RT (%)	N/A
N/A	Flare Traversable LT?	N/A	N/A	Flare Traversable RT?	N/A
N/A	Landing Length (in)	N/A	N/A	DWS Provided?	N/A
N/A	Landing Width (in)	N/A	N/A	DWS Contrast?	N/A
N/A	Landing Slope (%)	N/A	N/A	DWS Length (in)	N/A
N/A	Landing X Slope (%)	N/A	N/A	DWS Full Width?	N/A
N/A	Landing Curb? (Y/N)	N/A	N/A	DWS Offset (in)	N/A
N/A	Shared Landing?	N/A			
N/A	Gutter Ponding?	N/A	N/A	Gutter Slope (%)	N/A
N/A	Gutter Lip Ht (in)	N/A	N/A	Gutter X Slope (%)	N/A
N/A	Painted X Walk1?	No	N/A	Painted X Walk2?	N/A
	X Walk 1 Direction	To N		X Walk 2 Direction	N/A
N/A	X Walk 1 Width (in)	N/A	N/A	X Walk 2 Width (in)	N/A
	X Walk 1 Slope (%)	5.2		X Walk 2 Slope (%)	N/A
	X Walk 1 X Slope (%)	2.5		X Walk 2 X Slope (%)	N/A

N/A	Ramp inside XWalk1?	N/A	N/A	Ramp inside XWalk2?	N/A
	Road Slope (%)	N/A	N/A	Clear Space?	N/A
	Road X Slope (%)	N/A	N/A	Clear Space to XWalk (in)	N/A
N/A	Any Obstructions?	N/A	N/A	Storm Grate/Utility Hazard?	N/A
	Obstruction Type			Storm Grate/Utility Type	
		N/A			N/A
			Yes	Surface Condition? (G/P)	Good

Possible Solutions:

Remove & Replace Entire Ramp.

R304.5.1, R304.2.2, R304.5.3
