# Access Compliance Report

## Public Rights-of-Way

### (Curb Ramps)

| Intersection ID: 50344 | Main Street: KELBURN_LN | Cross Street: FENWAY_DR | Location: NW |

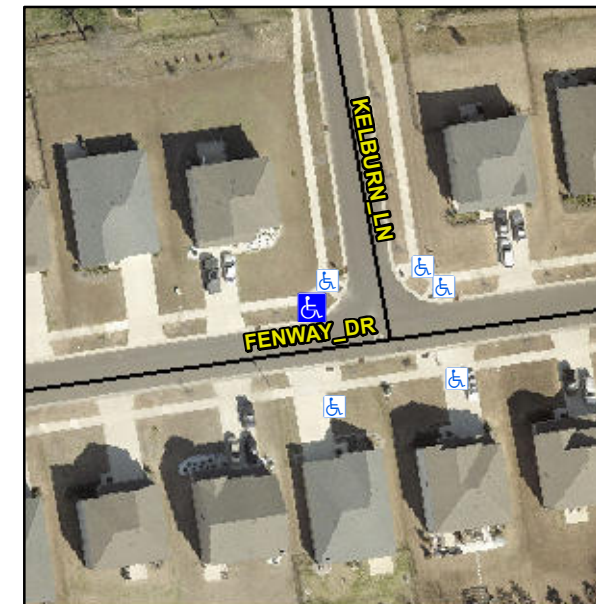
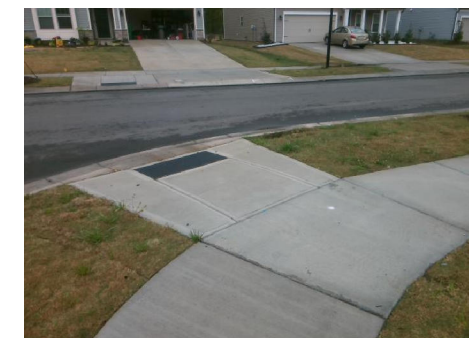
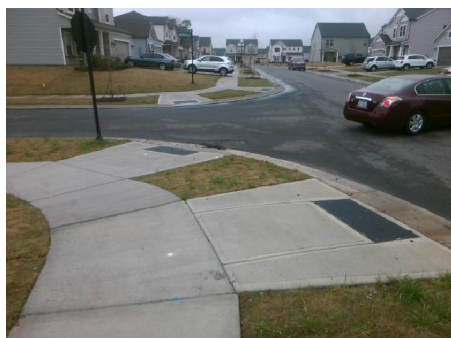
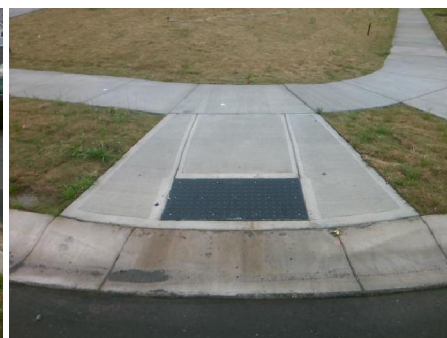
| ADA ID: 1094259E98E9 | Ramp Type: Perp | Initial Pass/Fail: Fail | Overall Compliance: No |

| Severity Score: 8.75 | | | |

**R304.5.1**

| Compliance | Description | Data | Compliance | Description | Data |
|---|---|---|---|---|---|
| No | Ramp Width (in) | 46.0 | Yes | Ramp XSlope (%) | 1.2 |

**Remove & Replace Entire Ramp.**
