# Access Compliance Report

## Public Rights-of-Way

### (Curb Ramps)

Intersection ID: 15373	Main Street: WINFIELD_DR	Cross Street: PIERSON_DR	Location: SE
ADA ID: 109C041317DF	Ramp Type: Perp	Initial Pass/Fail: Fail	Overall Compliance: No
Severity Score: 25			
Codes/Mitigation Info/Possible Solution		Field Measurements/Component Compliance

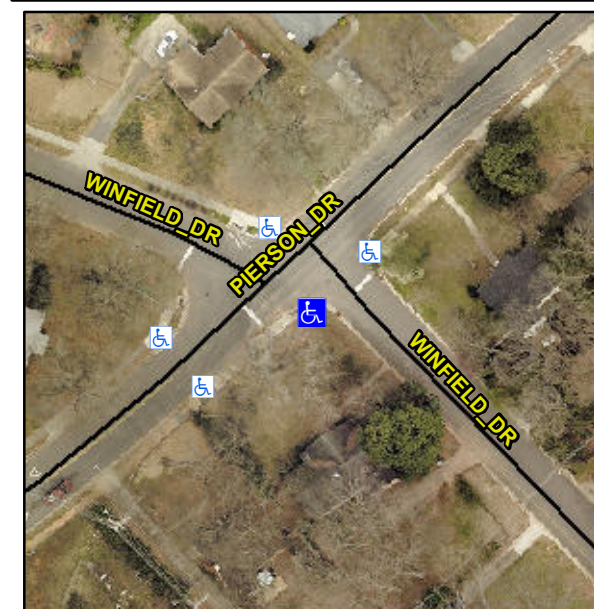
**Not Found, R304.2.2, R304.5.3**

Compliance	Description	Data	Compliance	Description	Data
N/A	Ramp Length (in)	59.5	No	Ramp Slope (%)	9.2
Yes	Ramp Width (in)	68.5	No	Ramp XSlope (%)	6.6
N/A	Flare Type LT	N/A	N/A	Flare Type RT	N/A
N/A	Flare Slope LT (%)	N/A	N/A	Flare Slope RT (%)	N/A
N/A	Flare Traversable LT?	N/A	N/A	Flare Traversable RT?	N/A
N/A	Landing Length (in)	N/A	N/A	DWS Provided?	N/A
N/A	Landing Width (in)	N/A	N/A	DWS Contrast?	N/A
N/A	Landing Slope (%)	N/A	N/A	DWS Length (in)	N/A
N/A	Landing X Slope (%)	N/A	N/A	DWS Full Width?	N/A
N/A	Landing Curb? (Y/N)	N/A	N/A	DWS Offset (in)	N/A
N/A	Shared Landing?	N/A			
N/A	Gutter Ponding?	Yes	N/A	Gutter Slope (%)	N/A
N/A	Gutter Lip Ht (in)	N/A	N/A	Gutter X Slope (%)	N/A
N/A	Painted X Walk1?	No	N/A	Painted X Walk2?	N/A
	X Walk 1 Direction	To NE		X Walk 2 Direction	N/A
N/A	X Walk 1 Width (in)	N/A	N/A	X Walk 2 Width (in)	N/A
	X Walk 1 Slope (%)	3.3		X Walk 2 Slope (%)	N/A
	X Walk 1 X Slope (%)	0.8		X Walk 2 X Slope (%)	N/A

N/A	Ramp inside XWalk1?	N/A	N/A	Ramp inside XWalk2?	N/A
	Road Slope (%)	N/A	N/A	Clear Space?	N/A
	Road X Slope (%)	N/A	N/A	Clear Space to XWalk (in)	N/A
N/A	Any Obstructions?	N/A	N/A	Storm Grate/Utility Hazard?	N/A
	Obstruction Type			Storm Grate/Utility Type	
		N/A			N/A
		Yes		Surface Condition? (G/P)	Good

**Remove & Replace Entire Ramp.**
