Access Compliance Report Public Rights-of-Way (Curb Ramps)

Intersection ID: 13994 Main Street: E 3RD ST **Cross Street: S TORRENCE ST** Location: N **Overall Compliance: No Severity Score:** 25 ADA ID: 109F9D2A43E9 Ramp Type: BlendTrans2 Initial Pass/Fail: Fail

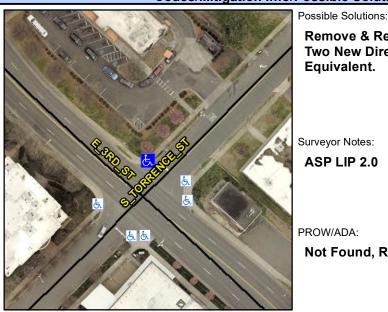
Not Found, R304.5.3

Street 1 Name Stop Condition-Street 1 Street 2 Name Stop Condition-Street 2 Remove & Replace Curb Ramp With Two New Directional Ramps or Equivalent.
