Access Compliance Report

Public Rights-of-Way

(Curb Ramps)

Intersection ID: 5741	Main Street: MALLARD_CREEK_RD	Cross Street: NEVIN_RD	Location: SE
ADA ID: 109FB1021AD8	Ramp Type: Perp	Initial Pass/Fail: Fail	Overall Compliance: No
			Severity Score: 21.25

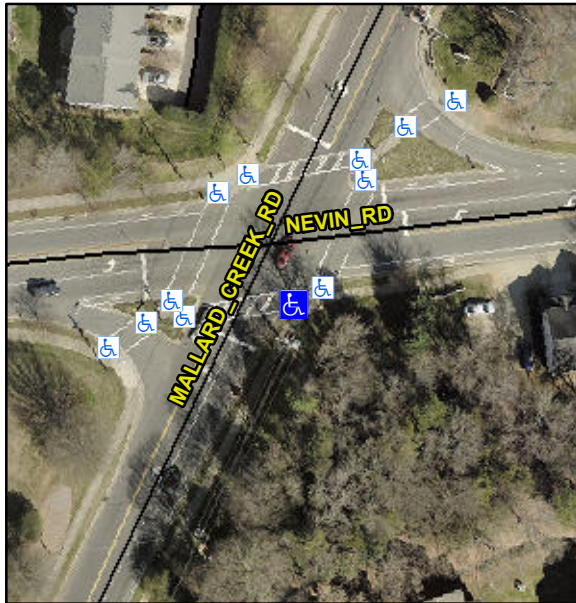
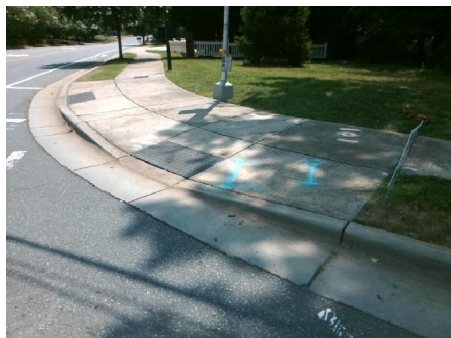
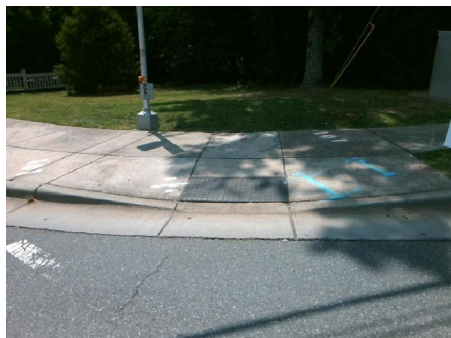
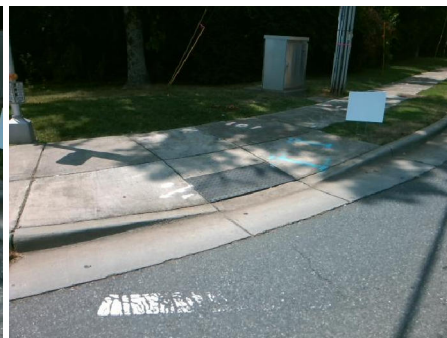
Not Found, R304.5.1, R304.2.2

Compliance	Description	Data	Compliance	Description	Data
N/A	Ramp Length (in)	49.0	No	Ramp Slope (%)	11.8
No	Ramp Width (in)	47.0	Yes	Ramp XSlope (%)	0.2
N/A	Flare Type LT	N/A	N/A	Flare Type RT	N/A
N/A	Flare Slope LT (%)	N/A	N/A	Flare Slope RT (%)	N/A
N/A	Flare Traversable LT?	N/A	N/A	Flare Traversable RT?	N/A
N/A	Landing Length (in)	N/A	N/A	DWS Provided?	N/A
N/A	Landing Width (in)	N/A	N/A	DWS Contrast?	N/A
N/A	Landing Slope (%)	N/A	N/A	DWS Length (in)	N/A
N/A	Landing X Slope (%)	N/A	N/A	DWS Full Width?	N/A
N/A	Landing Curb? (Y/N)	N/A	N/A	DWS Offset (in)	N/A
N/A	Shared Landing?	N/A			
N/A	Gutter Ponding?	N/A	N/A	Gutter Slope (%)	N/A
N/A	Gutter Lip Ht (in)	N/A	N/A	Gutter X Slope (%)	N/A
N/A	Painted X Walk1?	Yes	N/A	Painted X Walk2?	N/A
	X Walk 1 Direction	To W		X Walk 2 Direction	N/A
N/A	X Walk 1 Width (in)	117.0	N/A	X Walk 2 Width (in)	N/A
	X Walk 1 Slope (%)	1.4		X Walk 2 Slope (%)	N/A
	X Walk 1 X Slope (%)	1.2		X Walk 2 X Slope (%)	N/A

N/A	Ramp inside XWalk1?	Yes	N/A	Ramp inside XWalk2?	N/A
	Road Slope (%)	N/A	N/A	Clear Space?	N/A
	Road X Slope (%)	N/A	N/A	Clear Space to XWalk (in)	N/A
N/A	Any Obstructions?	N/A	N/A	Storm Grate/Utility Hazard?	N/A
	Obstruction Type			Storm Grate/Utility Type	
		N/A			N/A
			Yes	Surface Condition? (G/P)	Good

Remove & Replace Entire Ramp.
