Access Compliance Report

Public Rights-of-Way (Curb Ramps)

Intersection ID: 12788	Main Street: NASSAU_BV	Cross Street: SPRAGUE_AV	Location: NE
ADA ID: 10AB232A9874	Ramp Type: Directional1	Initial Pass/Fail: Fail	Overall Compliance: No
		Severity Score: 12.5

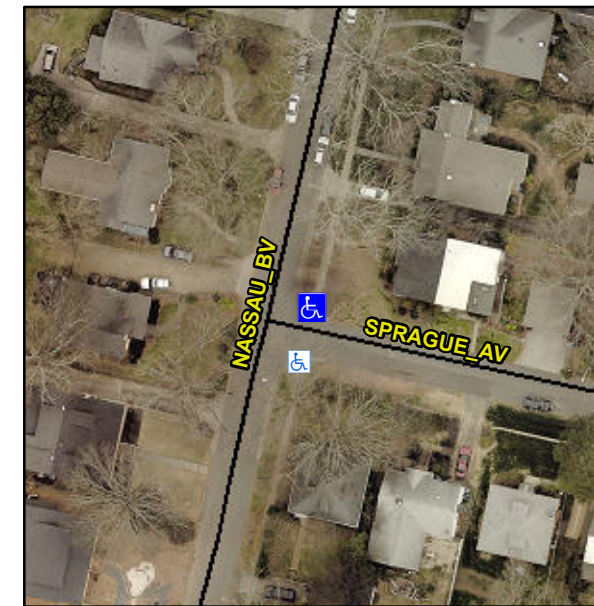
Compliance	Description	Data	Compliance	Description	Data
N/A	Ramp Length (in)	94.0	N/A	Grade Break?	N/A
Yes	Ramp Width (in)	49.0	N/A	Grade Break Slope (%)	0.0
No	Ramp Slope (%)	9.6	N/A	Grade Break XSlope (%)	0.0
Yes	Ramp XSlope (%)	0.7			
N/A	Flare Type LT	N/A	N/A	Flare Type RT	N/A
N/A	Flare Slope LT (%)	N/A	N/A	Flare Slope RT (%)	0.0
N/A	Flare Traversable LT?	N/A	N/A	Flare Traversable RT?	N/A
N/A	Landing Length (in)	0.0	N/A	DWS Provided?	N/A
N/A	Landing Width (in)	0.0	N/A	DWS Contrast?	N/A
N/A	Landing Slope (%)	0.0	N/A	DWS Length (in)	N/A
N/A	Landing X Slope (%)	0.0	N/A	DWS Full Width?	N/A
N/A	Landing Curb? (Y/N)	N/A	N/A	DWS Offset LT (in)	N/A
N/A	Shared Landing?	N/A	N/A	DWS Offset RT (in)	N/A
N/A	Gutter Ponding?	0.0	N/A	Gutter Slope (%)	N/A
N/A	Gutter Lip Ht (in)	0.0	N/A	Gutter X Slope (%)	N/A
N/A	Painted X Walk1?	No		Road Slope (%)	8.6
	X Walk 1 Direction	To S		Road X Slope (%)	7.4
	X Walk 1 Width (in)	N/A		Clear Space?	N/A

X Walk 1 Slope (%)	8.6	N/A	Clear Space to XWalk (in)	N/A
	X Walk 1 X Slope (%)	7.4	N/A	Storm Grate/Utility Hazard?	N/A
N/A	Ramp inside XWalk1?	N/A		Storm Grate/Utility Type	
N/A	Any Obstructions?	N/A			N/A
	Obstruction Type		Yes	Surface Condition? (G/P)	Good
			N/A	Curb Slope (%)	20.9

Possible Solutions:

Remove & Replace Entire Ramp.

R304.2.2

\$ 1600.00
