Access Compliance Report

Public Rights-of-Way

(Curb Ramps)

Intersection ID: 10005	Main Street: ROSLYN_AV	Cross Street: S_GARDNER_AV	Location: W
ADA ID: 10C0375E4282	Ramp Type: BlendTrans2	Initial Pass/Fail: Fail	Overall Compliance: No
		Severity Score: 10

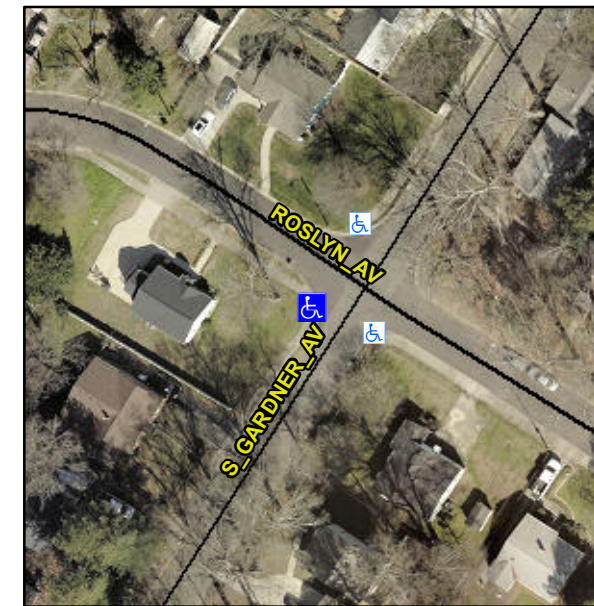
Compliance	Description	Data	Compliance	Description	Data
N/A	Ramp Length (in)	60.0	Yes	BlendTrans Slope (%)	2.4
No	Ramp Width (in)	47.0	No	BlendTrans XSlope (%)	3.1
N/A	Flare Type LT	N/A	N/A	Flare Type RT	N/A
N/A	Flare Slope LT (%)	N/A	N/A	Flare Slope RT (%)	N/A
N/A	Flare Traversable LT?	N/A	N/A	Flare Traversable RT?	N/A
N/A	Landing Length (in)	N/A	N/A	DWS Provided?	N/A
N/A	Landing Width (in)	N/A	N/A	DWS Contrast?	N/A
N/A	Landing Slope (%)	N/A	N/A	DWS Length (in)	N/A
N/A	Landing X Slope (%)	N/A	N/A	DWS Full Width?	N/A
N/A	Landing Curb? (Y/N)	N/A	N/A	DWS Offset (in)	N/A
N/A	Shared Landing?	N/A			
N/A	Gutter Ponding?	N/A	N/A	Gutter Slope (%)	N/A
N/A	Gutter Lip Ht (in)	N/A	N/A	Gutter X Slope (%)	N/A
N/A	Painted X Walk1?	No	N/A	Painted X Walk2?	No
	X Walk 1 Direction	To SE		X Walk 2 Direction	To NE
	X Walk 1 Width (in)	N/A		X Walk 2 Width (in)	N/A
	X Walk 1 Slope (%)	6.4		X Walk 2 Slope (%)	0.9
	X Walk 1 X Slope (%)	2.5		X Walk 2 X Slope (%)	6.1

N/A	Ramp inside XWalk1?	N/A	N/A	Ramp inside XWalk2?	N/A
	Road Slope (%)	2.8		Clear Space?	N/A
	Road X Slope (%)	4.3	N/A	Clear Space to XWalk (in)	N/A
N/A	Any Obstructions?	N/A	N/A	Storm Grate/Utility Hazard?	N/A
	Obstruction Type			Storm Grate/Utility Type	
		N/A			N/A
			Yes	Surface Condition? (G/P)	Good
			N/A	Curb Slope (%)	N/A

Remove & Replace Curb Ramp With Two New Directional Ramps or Equivalent.
