# Access Compliance Report

## Public Rights-of-Way

### (Curb Ramps)

Intersection ID: 9616	Main Street: BRIARWOOD_DR	Cross Street: THE_PLAZA	Location: NW
ADA ID: 10C75C07B9F0	Ramp Type: Perp	Initial Pass/Fail: Fail	Overall Compliance: No
		Severity Score: 22.5

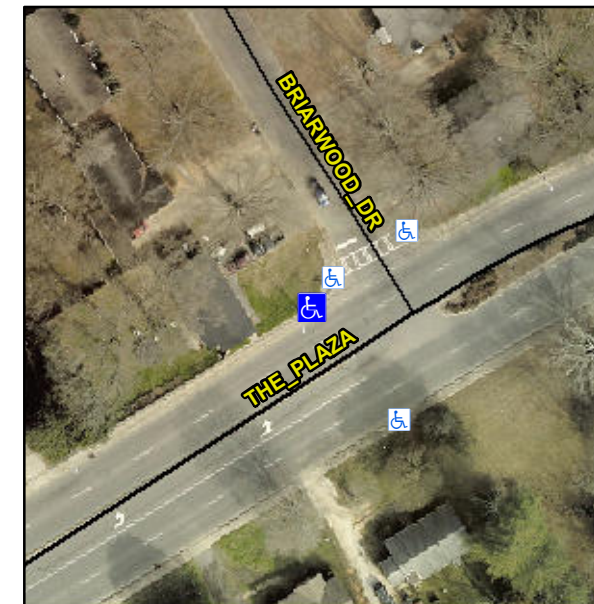
**Not Found, R304.5.1, R304.2.2, R304.5.3**

Compliance	Description	Data	Compliance	Description	Data
N/A	Ramp Length (in)	60.0	No	Ramp Slope (%)	8.6
No	Ramp Width (in)	47.5	No	Ramp XSlope (%)	3.8
N/A	Flare Type LT	N/A	N/A	Flare Type RT	N/A
N/A	Flare Slope LT (%)	N/A	N/A	Flare Slope RT (%)	N/A
N/A	Flare Traversable LT?	N/A	N/A	Flare Traversable RT?	N/A
N/A	Landing Length (in)	N/A	N/A	DWS Provided?	N/A
N/A	Landing Width (in)	N/A	N/A	DWS Contrast?	N/A
N/A	Landing Slope (%)	N/A	N/A	DWS Length (in)	N/A
N/A	Landing X Slope (%)	N/A	N/A	DWS Full Width?	N/A
N/A	Landing Curb? (Y/N)	N/A	N/A	DWS Offset (in)	N/A
N/A	Shared Landing?	N/A			
N/A	Gutter Ponding?	N/A	N/A	Gutter Slope (%)	N/A
N/A	Gutter Lip Ht (in)	N/A	N/A	Gutter X Slope (%)	N/A
N/A	Painted X Walk1?	No	N/A	Painted X Walk2?	N/A
	X Walk 1 Direction	To SE		X Walk 2 Direction	N/A
N/A	X Walk 1 Width (in)	N/A	N/A	X Walk 2 Width (in)	N/A
	X Walk 1 Slope (%)	0.8		X Walk 2 Slope (%)	N/A
	X Walk 1 X Slope (%)	2.0		X Walk 2 X Slope (%)	N/A

**Remove & Replace Entire Ramp.**
