Access Compliance Report

Public Rights-of-Way

(Curb Ramps)

Intersection ID: 44271	Main Street: BRITTNI_DAYLE_DR	Cross Street: TRAVIS_FLOYD_LN	Location: SW
ADA ID: 10C972C43D2E	Ramp Type: PerpDiag	Initial Pass/Fail: Fail	Overall Compliance: No
Severity Score: 8.75			
Codes/Mitigation Info/Possible Solution		Field Measurements/Component Compliance

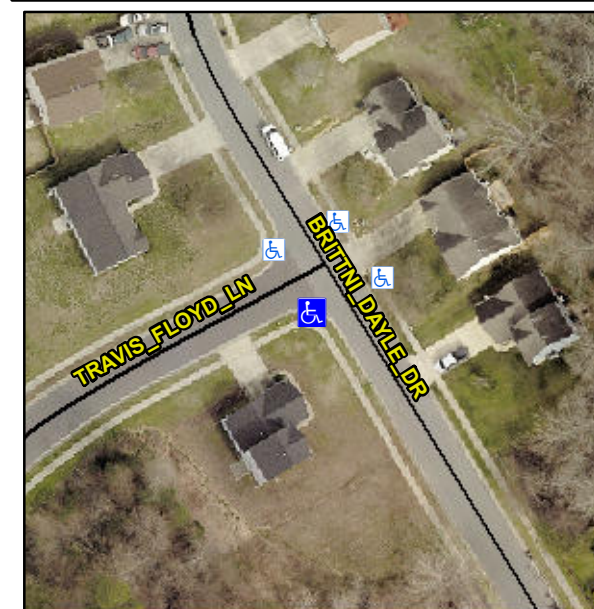
Compliance	Description	Data	Compliance	Description	Data
N/A	Ramp Length (in)	50.5	Yes	Ramp Slope (%)	6.2
No	Ramp Width (in)	38.0	Yes	Ramp XSlope (%)	1.8
N/A	Flare Type LT	N/A	N/A	Flare Type RT	N/A
N/A	Flare Slope LT (%)	N/A	N/A	Flare Slope RT (%)	N/A
N/A	Flare Traversable LT?	N/A	N/A	Flare Traversable RT?	N/A
N/A	Landing Length (in)	N/A	N/A	DWS Provided?	N/A
N/A	Landing Width (in)	N/A	N/A	DWS Contrast?	N/A
N/A	Landing Slope (%)	N/A	N/A	DWS Length (in)	N/A
N/A	Landing X Slope (%)	N/A	N/A	DWS Full Width?	N/A
N/A	Landing Curb? (Y/N)	N/A	N/A	DWS Offset (in)	N/A
N/A	Shared Landing?	N/A			
N/A	Gutter Ponding?	N/A	N/A	Gutter Slope (%)	N/A
N/A	Gutter Lip Ht (in)	N/A	N/A	Gutter X Slope (%)	N/A
N/A	Painted X Walk1?	No	N/A	Painted X Walk2?	No
	X Walk 1 Direction	To E		X Walk 2 Direction	To N
N/A	X Walk 1 Width (in)	N/A	N/A	X Walk 2 Width (in)	N/A
	X Walk 1 Slope (%)	3.9		X Walk 2 Slope (%)	7.1
	X Walk 1 X Slope (%)	5.5		X Walk 2 X Slope (%)	1.9

N/A	Ramp inside XWalk1?	N/A	N/A	Ramp inside XWalk2?	N/A
	Road Slope (%)	1.1	N/A	Clear Space?	N/A
	Road X Slope (%)	8.1	N/A	Clear Space to XWalk (in)	N/A
N/A	Any Obstructions?	N/A	N/A	Storm Grate/Utility Hazard?	N/A
	Obstruction Type			Storm Grate/Utility Type	
		N/A			N/A
			Yes	Surface Condition? (G/P)	Good

Possible Solutions:

Remove & Replace Curb Ramp With Two New Directional Ramps or Equivalent.

Not Found, R304.5.1
