# Access Compliance Report

## Public Rights-of-Way

### (Curb Ramps)

Intersection ID: 16185	Main Street: DORIS_AV	Cross Street: RICHLAND_DR	Location: E
ADA ID: 10CAAE77C727	Ramp Type: BlendTrans1	Initial Pass/Fail: Fail	Overall Compliance: No
			Severity Score: 18.75

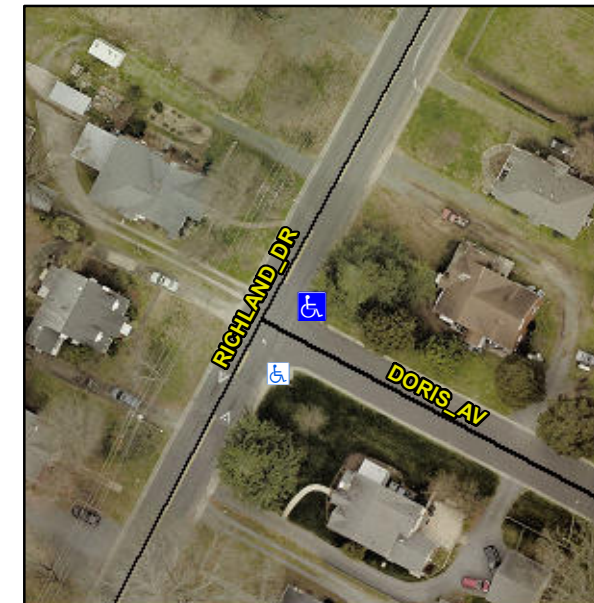
**NO RT SW**

**R304.5.1, R304.5.3**

Compliance	Description	Data	Compliance	Description	Data
N/A	Ramp Length (in)	56.0	Yes	BlendTrans Slope (%)	2.9
No	Ramp Width (in)	32.0	No	BlendTrans XSlope (%)	2.1
N/A	Flare Type LT	N/A	N/A	Flare Type RT	N/A
N/A	Flare Slope LT (%)	N/A	N/A	Flare Slope RT (%)	N/A
N/A	Flare Traversable LT?	N/A	N/A	Flare Traversable RT?	N/A
N/A	Landing Length (in)	N/A	N/A	DWS Provided?	N/A
N/A	Landing Width (in)	N/A	N/A	DWS Contrast?	N/A
N/A	Landing Slope (%)	N/A	N/A	DWS Length (in)	N/A
N/A	Landing X Slope (%)	N/A	N/A	DWS Full Width?	N/A
N/A	Landing Curb? (Y/N)	N/A	N/A	DWS Offset (in)	N/A
N/A	Shared Landing?	N/A			
N/A	Gutter Ponding?	N/A	N/A	Gutter Slope (%)	N/A
N/A	Gutter Lip Ht (in)	N/A	N/A	Gutter X Slope (%)	N/A
N/A	Painted X Walk1?	No	N/A	Painted X Walk2?	N/A
	X Walk 1 Direction	To SW		X Walk 2 Direction	N/A
	X Walk 1 Width (in)	N/A		X Walk 2 Width (in)	N/A
	X Walk 1 Slope (%)	0.2		X Walk 2 Slope (%)	N/A
	X Walk 1 X Slope (%)	0.6		X Walk 2 X Slope (%)	N/A

N/A	Ramp inside XWalk1?	N/A	N/A	Ramp inside XWalk2?	N/A
	Road Slope (%)	0.6		Clear Space?	N/A
	Road X Slope (%)	0.2	N/A	Clear Space to XWalk (in)	N/A
N/A	Any Obstructions?	N/A	N/A	Storm Grate/Utility Hazard?	N/A
	Obstruction Type			Storm Grate/Utility Type	
		N/A			N/A
			Yes	Surface Condition? (G/P)	Good
			N/A	Curb Slope (%)	1.3

**Remove & Replace Curb Ramp With Two New Directional Ramps or Equivalent.**

Total Cost: \$ 3200.00
