Access Compliance Report

Public Rights-of-Way

(Curb Ramps)

Intersection ID: 4943	Main Street: ICON_WY	Cross Street: LAWNMEADOW_DR	Location: NW
ADA ID: 10CE3F4B2E78	Ramp Type: BlendTrans1	Initial Pass/Fail: Fail	Overall Compliance: No
		Severity Score: 12.5

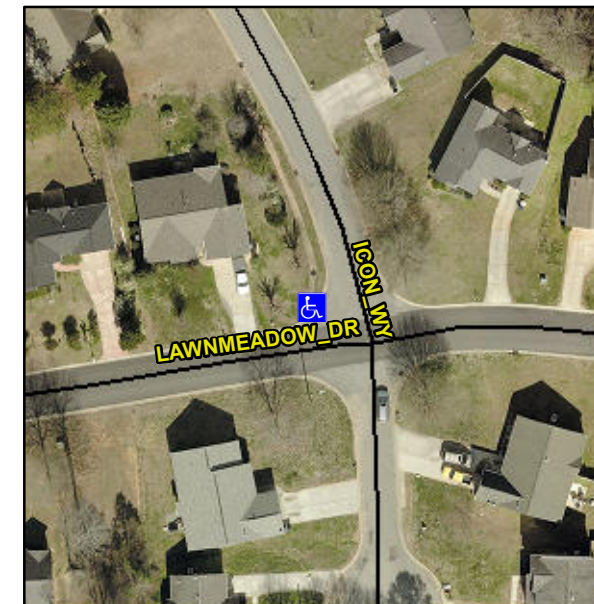
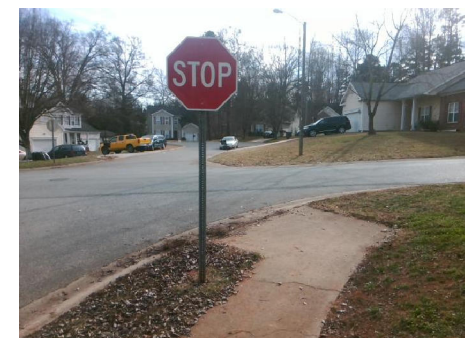
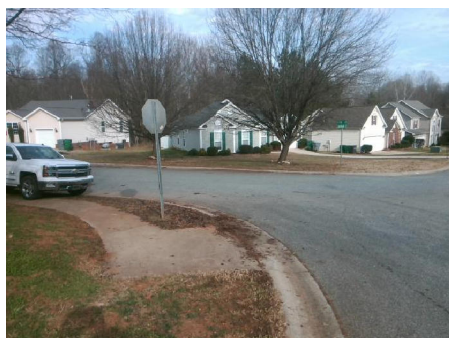
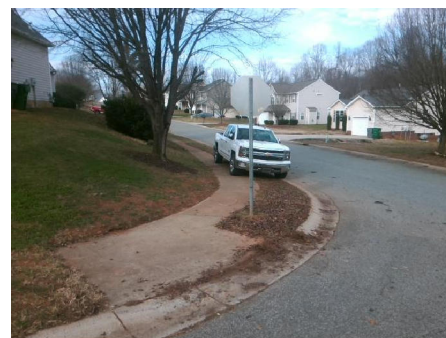
NO LT SW

Compliance	Description	Data	Compliance	Description	Data
N/A	Ramp Length (in)	50.0	Yes	BlendTrans Slope (%)	3.3
Yes	Ramp Width (in)	48.0	No	BlendTrans XSlope (%)	5.6
N/A	Flare Type LT	N/A	N/A	Flare Type RT	N/A
N/A	Flare Slope LT (%)	N/A	N/A	Flare Slope RT (%)	N/A
N/A	Flare Traversable LT?	N/A	N/A	Flare Traversable RT?	N/A
N/A	Landing Length (in)	N/A	N/A	DWS Provided?	N/A
N/A	Landing Width (in)	N/A	N/A	DWS Contrast?	N/A
N/A	Landing Slope (%)	N/A	N/A	DWS Length (in)	N/A
N/A	Landing X Slope (%)	N/A	N/A	DWS Full Width?	N/A
N/A	Landing Curb? (Y/N)	N/A	N/A	DWS Offset (in)	N/A
N/A	Shared Landing?	N/A			
N/A	Gutter Ponding?	N/A	N/A	Gutter Slope (%)	N/A
N/A	Gutter Lip Ht (in)	N/A	N/A	Gutter X Slope (%)	N/A
N/A	Painted X Walk1?	No	N/A	Painted X Walk2?	No
	X Walk 1 Direction	To S		X Walk 2 Direction	To E
	X Walk 1 Width (in)	N/A		X Walk 2 Width (in)	N/A
	X Walk 1 Slope (%)	2.3		X Walk 2 Slope (%)	N/A
	X Walk 1 X Slope (%)	5.0		X Walk 2 X Slope (%)	N/A

N/A	Ramp inside XWalk1?	N/A	N/A	Ramp inside XWalk2?	N/A
	Road Slope (%)	5.0		Clear Space?	N/A
	Road X Slope (%)	2.3	N/A	Clear Space to XWalk (in)	N/A
N/A	Any Obstructions?	N/A	N/A	Storm Grate/Utility Hazard?	N/A
	Obstruction Type			Storm Grate/Utility Type	
		N/A			N/A
			Yes	Surface Condition? (G/P)	Good
			N/A	Curb Slope (%)	2.9

Remove & Replace Curb Ramp With Two New Directional Ramps or Equivalent.

R304.5.3
