# Access Compliance Report

## Public Rights-of-Way

### (Curb Ramps)

| Intersection ID: 14512 | Main Street: CARONIA_ST | Cross Street: ROSS_AV | Location: SW |

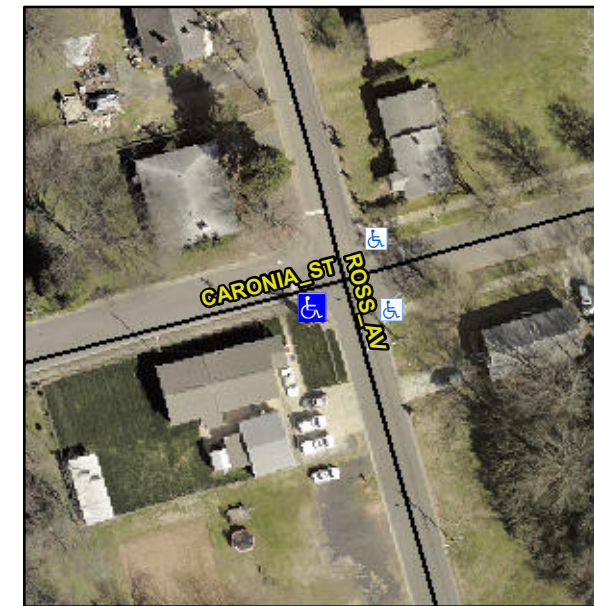
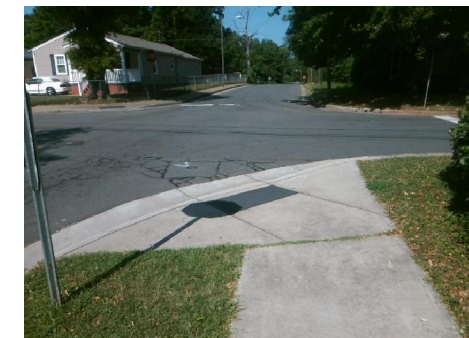
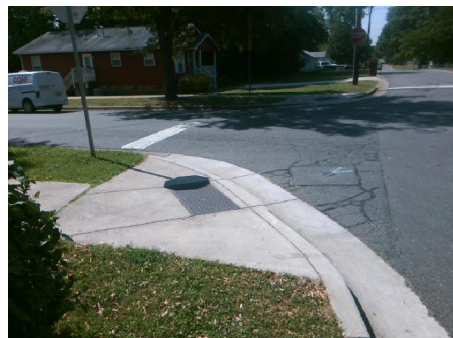
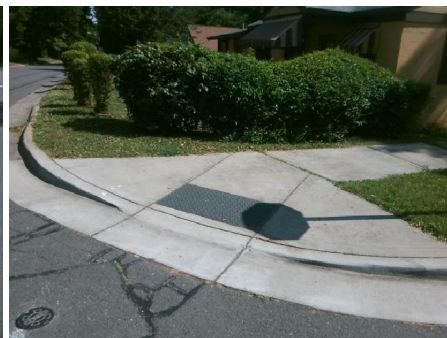
| ADA ID: 10D0BE2A694D | Ramp Type: PerpDiag | Initial Pass/Fail: Pass | Overall Compliance: No |

**R305.2**

| Compliance | Description | Data | Compliance | Description | Data |
|---|---|---|---|---|---|
| N/A | Landing Curb? (Y/N) | No | No | DWS Offset (in) | 5.0 |

**Remove & Replace Detectable Warning System.**

\$ 800.00
