Access Compliance Report

Public Rights-of-Way (Curb Ramps)

Intersection ID: 44822	Main Street: GOLDEN RIDGE LN	Cross Street: HIRAM ST	Location: SW
ADA ID: 10DA752B574F	Ramp Type: Perp	Initial Pass/Fail: Fail	Overall Compliance: No
Severity Score: 21.25			
Codes/Mitigation Info/Possible Solution		Field Measurements/Component Compliance

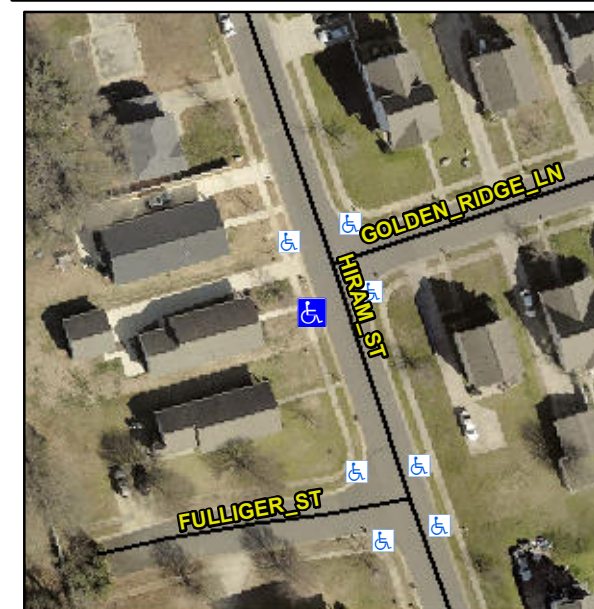
Compliance	Description	Data	Compliance	Description	Data
N/A	Ramp Length (in)	48.0	Yes	Ramp Slope (%)	5.6
No	Ramp Width (in)	47.0	No	Ramp XSlope (%)	5.2
N/A	Flare Type LT	N/A	N/A	Flare Type RT	N/A
N/A	Flare Slope LT (%)	N/A	N/A	Flare Slope RT (%)	N/A
N/A	Flare Traversable LT?	N/A	N/A	Flare Traversable RT?	N/A
N/A	Landing Length (in)	N/A	N/A	DWS Provided?	N/A
N/A	Landing Width (in)	N/A	N/A	DWS Contrast?	N/A
N/A	Landing Slope (%)	N/A	N/A	DWS Length (in)	N/A
N/A	Landing X Slope (%)	N/A	N/A	DWS Full Width?	N/A
N/A	Landing Curb? (Y/N)	N/A	N/A	DWS Offset (in)	N/A
N/A	Shared Landing?	N/A			
N/A	Gutter Ponding?	N/A	N/A	Gutter Slope (%)	N/A
N/A	Gutter Lip Ht (in)	N/A	N/A	Gutter X Slope (%)	N/A
N/A	Painted X Walk1?	No	N/A	Painted X Walk2?	N/A
	X Walk 1 Direction	To E		X Walk 2 Direction	N/A
N/A	X Walk 1 Width (in)	N/A	N/A	X Walk 2 Width (in)	N/A
	X Walk 1 Slope (%)	1.5		X Walk 2 Slope (%)	N/A
	X Walk 1 X Slope (%)	5.2		X Walk 2 X Slope (%)	N/A

N/A	Ramp inside XWalk1?	N/A	N/A	Ramp inside XWalk2?	N/A
	Road Slope (%)	N/A	N/A	Clear Space?	N/A
	Road X Slope (%)	N/A	N/A	Clear Space to XWalk (in)	N/A
N/A	Any Obstructions?	N/A	N/A	Storm Grate/Utility Hazard?	N/A
	Obstruction Type			Storm Grate/Utility Type	
		N/A			N/A
			Yes	Surface Condition? (G/P)	Good

Possible Solutions:

Remove & Replace Entire Ramp.

R304.5.1, R304.5.3
