# Access Compliance Report

## Public Rights-of-Way

### (Curb Ramps)

Intersection ID: 17169	Main Street: IDLEWILD_RD	Cross Street: CEDARS_EAST_CT	Location: NW
ADA ID: 10E2C3C52A54	Ramp Type: PerpDiag	Initial Pass/Fail: Fail	Overall Compliance: No
			Severity Score: 13.75

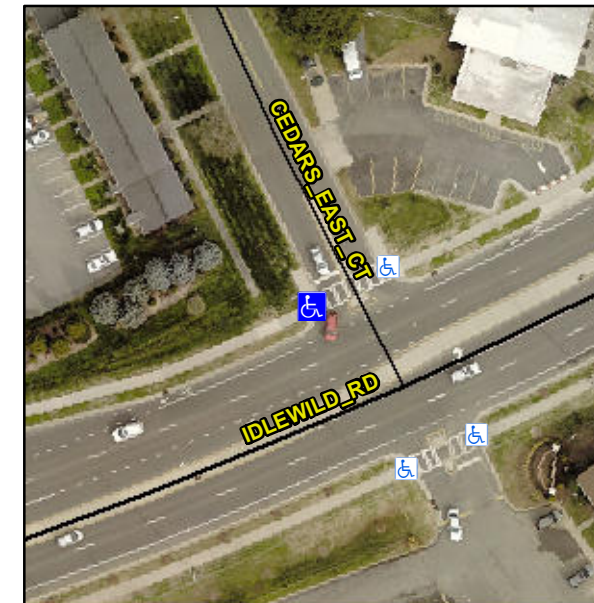
**Not Found, R304.2.2, R304.5.3**

Compliance	Description	Data	Compliance	Description	Data
N/A	Ramp Length (in)	80.0	No	Ramp Slope (%)	8.7
Yes	Ramp Width (in)	48.0	No	Ramp XSlope (%)	3.2
N/A	Flare Type LT	N/A	N/A	Flare Type RT	N/A
N/A	Flare Slope LT (%)	N/A	N/A	Flare Slope RT (%)	N/A
N/A	Flare Traversable LT?	N/A	N/A	Flare Traversable RT?	N/A
N/A	Landing Length (in)	N/A	N/A	DWS Provided?	N/A
N/A	Landing Width (in)	N/A	N/A	DWS Contrast?	N/A
N/A	Landing Slope (%)	N/A	N/A	DWS Length (in)	N/A
N/A	Landing X Slope (%)	N/A	N/A	DWS Full Width?	N/A
N/A	Landing Curb? (Y/N)	N/A	N/A	DWS Offset (in)	N/A
N/A	Shared Landing?	N/A			
N/A	Gutter Ponding?	N/A	N/A	Gutter Slope (%)	N/A
N/A	Gutter Lip Ht (in)	N/A	N/A	Gutter X Slope (%)	N/A
N/A	Painted X Walk1?	No	N/A	Painted X Walk2?	Yes
	X Walk 1 Direction	To SE		X Walk 2 Direction	To NE
N/A	X Walk 1 Width (in)	N/A	N/A	X Walk 2 Width (in)	111.0
	X Walk 1 Slope (%)	4.8		X Walk 2 Slope (%)	2.0
	X Walk 1 X Slope (%)	1.8		X Walk 2 X Slope (%)	3.9

N/A	Ramp inside XWalk1?	N/A	N/A	Ramp inside XWalk2?	Yes
	Road Slope (%)	2.4	N/A	Clear Space?	N/A
	Road X Slope (%)	2.8	N/A	Clear Space to XWalk (in)	N/A
N/A	Any Obstructions?	N/A	N/A	Storm Grate/Utility Hazard?	N/A
	Obstruction Type			Storm Grate/Utility Type	
		N/A			N/A
			Yes	Surface Condition? (G/P)	Good

**Remove & Replace Curb Ramp With Two New Directional Ramps or Equivalent.**

Total Cost: \$ 3200.00
