Access Compliance Report

Public Rights-of-Way

(Curb Ramps)

Intersection ID: 19064	Main Street: GROSNER_PL	Cross Street: RAMA_RD	Location:	W
ADA ID: 10E2CB040B9D	Ramp Type: PerpDiag	Initial Pass/Fail: Fail	Overall Compliance: No	Severity Score: 25
Codes/Mitigation Info/Possible Solution		Field Measurements/Component Compliance

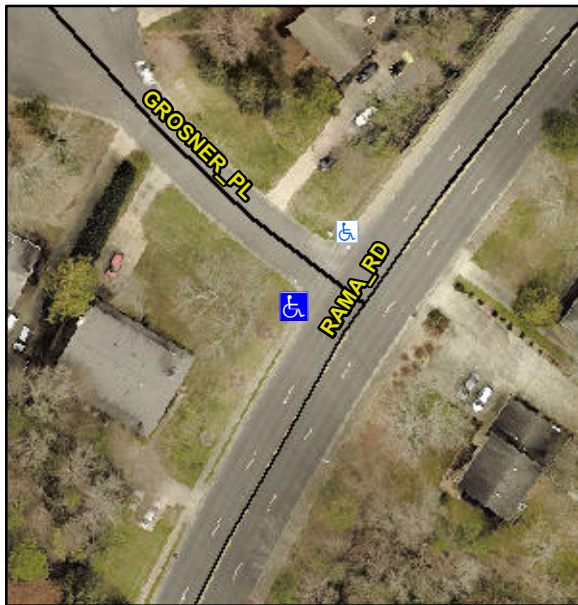
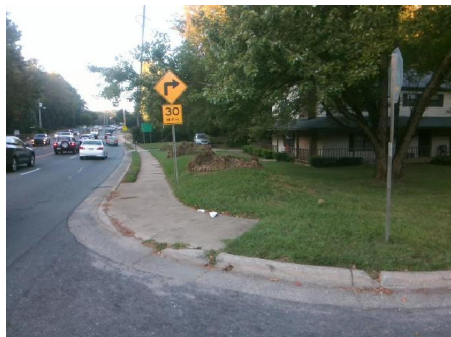
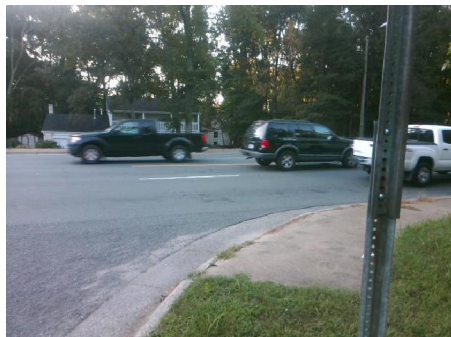
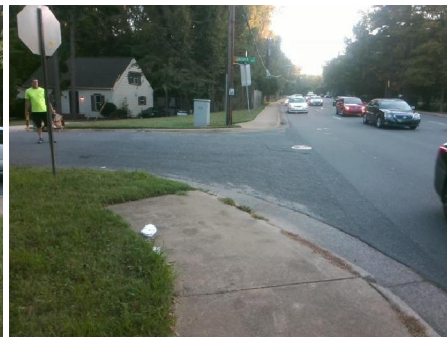
Not Found, R304.2.2, R304.5.3

Compliance	Description	Data	Compliance	Description	Data
N/A	Ramp Length (in)	70.0	No	Ramp Slope (%)	10.3
Yes	Ramp Width (in)	48.0	No	Ramp XSlope (%)	6.6
N/A	Flare Type LT	N/A	N/A	Flare Type RT	N/A
N/A	Flare Slope LT (%)	N/A	N/A	Flare Slope RT (%)	N/A
N/A	Flare Traversable LT?	N/A	N/A	Flare Traversable RT?	N/A
N/A	Landing Length (in)	N/A	N/A	DWS Provided?	N/A
N/A	Landing Width (in)	N/A	N/A	DWS Contrast?	N/A
N/A	Landing Slope (%)	N/A	N/A	DWS Length (in)	N/A
N/A	Landing X Slope (%)	N/A	N/A	DWS Full Width?	N/A
N/A	Landing Curb? (Y/N)	N/A	N/A	DWS Offset (in)	N/A
N/A	Shared Landing?	N/A			
N/A	Gutter Ponding?	N/A	N/A	Gutter Slope (%)	N/A
N/A	Gutter Lip Ht (in)	N/A	N/A	Gutter X Slope (%)	N/A
N/A	Painted X Walk1?	No	N/A	Painted X Walk2?	No
	X Walk 1 Direction	To SE		X Walk 2 Direction	To NE
N/A	X Walk 1 Width (in)	N/A	N/A	X Walk 2 Width (in)	N/A
	X Walk 1 Slope (%)	6.3		X Walk 2 Slope (%)	4.2
	X Walk 1 X Slope (%)	0.2		X Walk 2 X Slope (%)	4.2

N/A	Ramp inside XWalk1?	N/A	N/A	Ramp inside XWalk2?	N/A
	Road Slope (%)	1.1	N/A	Clear Space?	N/A
	Road X Slope (%)	3.5	N/A	Clear Space to XWalk (in)	N/A
N/A	Any Obstructions?	N/A	N/A	Storm Grate/Utility Hazard?	N/A
	Obstruction Type			Storm Grate/Utility Type	
		N/A			N/A
			Yes	Surface Condition? (G/P)	Good

Possible Solutions:

Remove & Replace Curb Ramp With Two New Directional Ramps or Equivalent.
