Access Compliance Report

Public Rights-of-Way

(Curb Ramps)

Intersection ID: 12216	Main Street: ASHLEY_RD	Cross Street: LUMINA_AV	Location: W
ADA ID: 10E45D8AEF90	Ramp Type: PerpDiag	Initial Pass/Fail: Fail	Overall Compliance: No
		Severity Score: 8.75

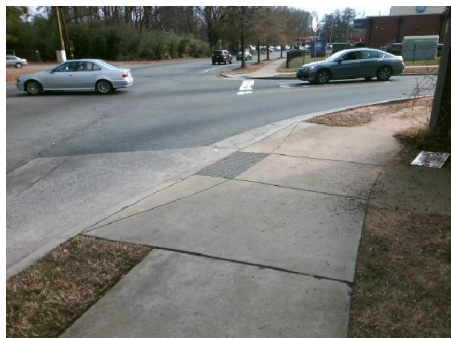
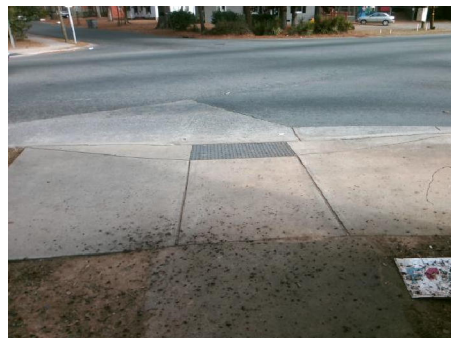
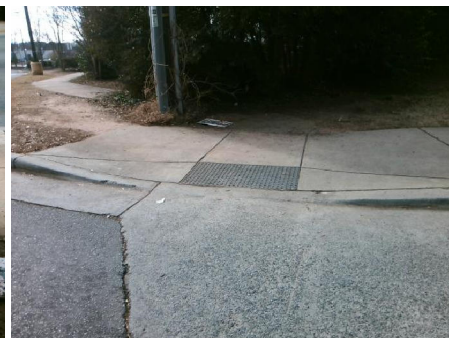
Compliance	Description	Data	Compliance	Description	Data
N/A	Ramp Length (in)	25.0	Yes	Ramp Slope (%)	6.7
No	Ramp Width (in)	47.5	Yes	Ramp XSlope (%)	1.1
N/A	Flare Type LT	N/A	N/A	Flare Type RT	N/A
N/A	Flare Slope LT (%)	N/A	N/A	Flare Slope RT (%)	N/A
N/A	Flare Traversable LT?	N/A	N/A	Flare Traversable RT?	N/A
N/A	Landing Length (in)	N/A	N/A	DWS Provided?	N/A
N/A	Landing Width (in)	N/A	N/A	DWS Contrast?	N/A
N/A	Landing Slope (%)	N/A	N/A	DWS Length (in)	N/A
N/A	Landing X Slope (%)	N/A	N/A	DWS Full Width?	N/A
N/A	Landing Curb? (Y/N)	N/A	N/A	DWS Offset (in)	N/A
N/A	Shared Landing?	N/A			
N/A	Gutter Ponding?	N/A	N/A	Gutter Slope (%)	N/A
N/A	Gutter Lip Ht (in)	N/A	N/A	Gutter X Slope (%)	N/A
N/A	Painted X Walk1?	No	N/A	Painted X Walk2?	No
	X Walk 1 Direction	To SE		X Walk 2 Direction	To NE
N/A	X Walk 1 Width (in)	N/A	N/A	X Walk 2 Width (in)	N/A
	X Walk 1 Slope (%)	1.4		X Walk 2 Slope (%)	2.6
	X Walk 1 X Slope (%)	1.8		X Walk 2 X Slope (%)	3.8

N/A	Ramp inside XWalk1?	N/A	N/A	Ramp inside XWalk2?	N/A
	Road Slope (%)	0.5	N/A	Clear Space?	N/A
	Road X Slope (%)	3.5	N/A	Clear Space to XWalk (in)	N/A
N/A	Any Obstructions?	N/A	N/A	Storm Grate/Utility Hazard?	N/A
	Obstruction Type			Storm Grate/Utility Type	
		N/A			N/A
			Yes	Surface Condition? (G/P)	Good

Remove & Replace Curb Ramp With Two New Directional Ramps or Equivalent.
