Access Compliance Report Public Rights-of-Way (Curb Ramps)

Intersection ID: 15167 Main Street: GOLDFIELDS_DR Cross Street: OLDE_SAVANNAH_RD Location: SW

ADA ID: 10EEBE4C3C8E Ramp Type: PerpDiag Initial Pass/Fail: Fail Overall Compliance: No Severity Score: 13.75

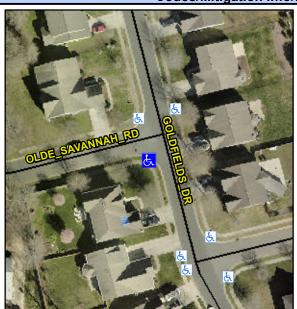
Not Found, R304.2.2, R304.5.3

Field Measurements/Component Compliance						
Comp	liance Description	Data	Compl	liance	Description	Data
N/A	Ramp Length (in)	47.0	No	Ramp	Slope (%)	8.5
Yes	Ramp Width (in)	48.0	No	Ramp	XSlope (%)	3.3
N/A	Flare Type LT	N/A	N/A	Flare	Type RT	N/A
N/A	Flare Slope LT (%)	N/A	N/A	Flare	Slope RT (%)	N/A
N/A	Flare Traversable LT?	N/A	N/A	Flare	Traversable RT?	N/A
N/A	Landing Length (in)	N/A	N/A	DWS	Provided?	N/A
N/A	Landing Width (in)	N/A	N/A	DWS	Contrast?	N/A
N/A	Landing Slope (%)	N/A	N/A	DWS	Length (in)	N/A
N/A	Landing X Slope (%)	N/A	N/A	DWS	Full Width?	N/A
N/A	Landing Curb? (Y/N)	N/A	N/A	DWS	Offset (in)	N/A
N/A	Shared Landing?	N/A				
N/A	Gutter Ponding?	N/A	N/A	Gutte	r Slope (%)	N/A
N/A	Gutter Lip Ht (in)	N/A	N/A	Gutte	r X Slope (%)	N/A
N/A	Painted X Walk1?	No	N/A	Painte	ed X Walk2?	No
	X Walk 1 Direction	To E		X Wa	lk 2 Direction	To N
N/A	X Walk 1 Width (in)	N/A	N/A	X Wa	lk 2 Width (in)	N/A
	X Walk 1 Slope (%)	3.0		X Wa	lk 2 Slope (%)	0.8

X Walk 1 X Slope (%)	0.6		X Wa	lk 2 X Slope (%)	3.0
N/A	Ramp inside XWalk1?	N/A	N/A	Ramp	inside XWalk2?	N/A
	Road Slope (%)	2.5	N/A	Clear	Space?	N/A
	Road X Slope (%)	2.3	N/A	Clear	Space to XWalk (in)	N/A
N/A	Any Obstructions?	N/A	N/A	Storm	Grate/Utility Hazard?	N/A
	Obstruction Type			Storm	Grate/Utility Type	
		N/A				N/A
			Yes	Surfa	ce Condition? (G/P)	Good

Remove & Replace Curb Ramp With Two New Directional Ramps or Equivalent.

Total Cost: \$ 3200.00
