Access Compliance Report

Public Rights-of-Way

(Curb Ramps)

Intersection ID: N/A	Main Street: ELGIN_MOOR_RD	Cross Street: DOUGLAS_PALACE_CT	Location: SW
ADA ID: 10F449E5F3F3	Ramp Type: Perp	Initial Pass/Fail: Fail	Overall Compliance: No
		Severity Score: 12.5

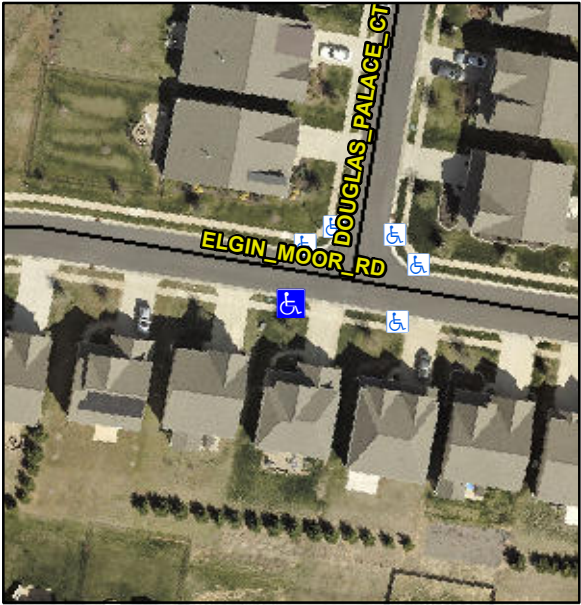
Possible Solutions:		Compliance	Description	Data
	Remove & Replace Entire Ramp.		N/A	Ramp Length (in)	47.0
			Yes	Ramp Width (in)	48.0
			N/A	Flare Type LT	N/A
			N/A	Flare Slope LT (%)	N/A
			N/A	Flare Traversable LT?	N/A
			N/A	Landing Length (in)	N/A
			N/A	Landing Width (in)	N/A
			N/A	Landing Slope (%)	N/A
			N/A	Landing X Slope (%)	N/A
<p>Surveyor Notes:</p> <p>N/A</p> <p>PROW/ADA:</p> <p>R304.2.2</p>			N/A	Flare Type RT	N/A
			N/A	Flare Slope RT (%)	N/A
			N/A	Flare Traversable RT?	N/A
			N/A	DWS Provided?	N/A
			N/A	DWS Contrast?	N/A
			N/A	DWS Length (in)	N/A
			N/A	DWS Full Width?	N/A
			N/A	DWS Offset (in)	N/A
			N/A	Gutter Ponding?	N/A
			N/A	Gutter Lip Ht (in)	1.0
			N/A	Painted X Walk1?	No
				X Walk 1 Direction	To NE
			N/A	X Walk 1 Width (in)	N/A
				X Walk 1 Slope (%)	1.3
				X Walk 1 X Slope (%)	0.9
			N/A	Ramp inside XWalk1?	N/A
