Access Compliance Report

Public Rights-of-Way

(Curb Ramps)

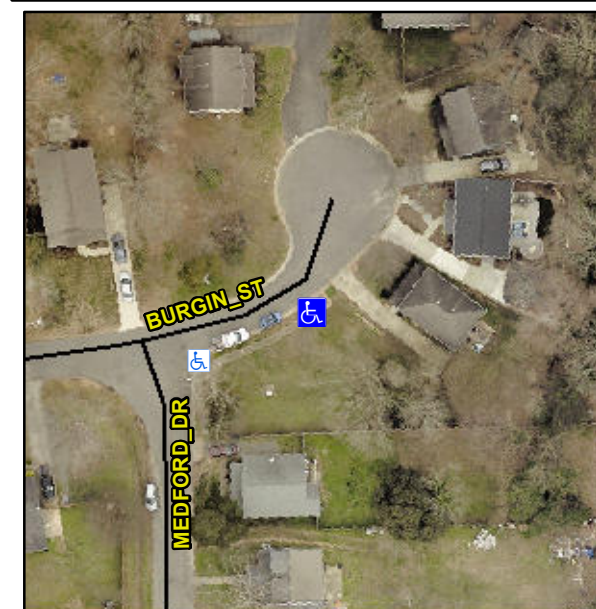
Intersection ID: 10019048	Main Street: BURGIN_ST	Cross Street: N/A	Location: S
ADA ID: 1114F552F456	Ramp Type: Perp	Initial Pass/Fail: Fail	Overall Compliance: No
Severity Score: 10			
Codes/Mitigation Info/Possible Solution		Field Measurements/Component Compliance

PROW/ADA:

Not Found, R304.5.1, R304.5.3

Compliance	Description	Data	Compliance	Description	Data
N/A	Ramp Length (in)	99.0	Yes	Ramp Slope (%)	5.5
No	Ramp Width (in)	47.0	No	Ramp XSlope (%)	2.9
N/A	Flare Type LT	N/A	N/A	Flare Type RT	N/A
N/A	Flare Slope LT (%)	N/A	N/A	Flare Slope RT (%)	N/A
N/A	Flare Traversable LT?	N/A	N/A	Flare Traversable RT?	N/A
N/A	Landing Length (in)	N/A	N/A	DWS Provided?	N/A
N/A	Landing Width (in)	N/A	N/A	DWS Contrast?	N/A
N/A	Landing Slope (%)	N/A	N/A	DWS Length (in)	N/A
N/A	Landing X Slope (%)	N/A	N/A	DWS Full Width?	N/A
N/A	Landing Curb? (Y/N)	N/A	N/A	DWS Offset (in)	N/A
N/A	Shared Landing?	N/A			
N/A	Gutter Ponding?	N/A	N/A	Gutter Slope (%)	N/A
N/A	Gutter Lip Ht (in)	N/A	N/A	Gutter X Slope (%)	N/A
N/A	Painted X Walk1?	No	N/A	Painted X Walk2?	N/A
	X Walk 1 Direction	To N		X Walk 2 Direction	N/A
N/A	X Walk 1 Width (in)	N/A	N/A	X Walk 2 Width (in)	N/A
	X Walk 1 Slope (%)	4.4		X Walk 2 Slope (%)	N/A
	X Walk 1 X Slope (%)	0.7		X Walk 2 X Slope (%)	N/A

N/A	Ramp inside XWalk1?	N/A	N/A	Ramp inside XWalk2?	N/A
	Road Slope (%)	N/A	N/A	Clear Space?	N/A
	Road X Slope (%)	N/A	N/A	Clear Space to XWalk (in)	N/A
N/A	Any Obstructions?	N/A	N/A	Storm Grate/Utility Hazard?	N/A
	Obstruction Type			Storm Grate/Utility Type	
		N/A			N/A
		Yes		Surface Condition? (G/P)	Good

Possible Solutions:

Remove & Replace Entire Ramp.

Total Cost: \$ 1850.00
