# Access Compliance Report

## Public Rights-of-Way

### (Curb Ramps)

Intersection ID: 12848	Main Street: S_MINT_ST	Cross Street: W_PALMER_ST	Location: N
ADA ID: 1117E6766847	Ramp Type: PerpDiag	Initial Pass/Fail: Fail	Overall Compliance: No
Severity Score: 37.5			
Codes/Mitigation Info/Possible Solution		Field Measurements/Component Compliance

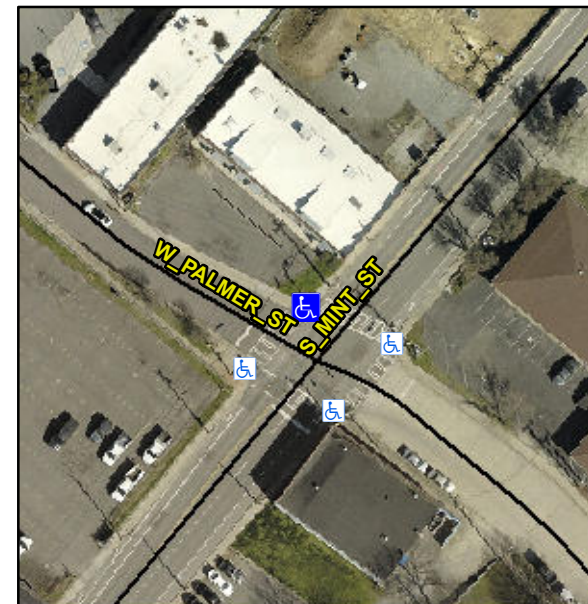
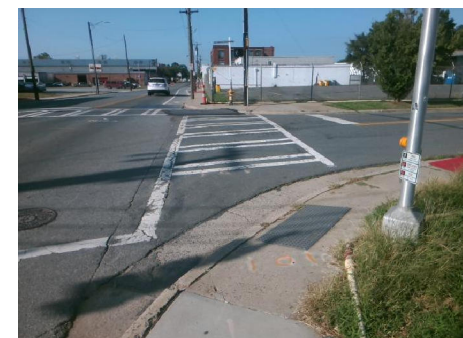
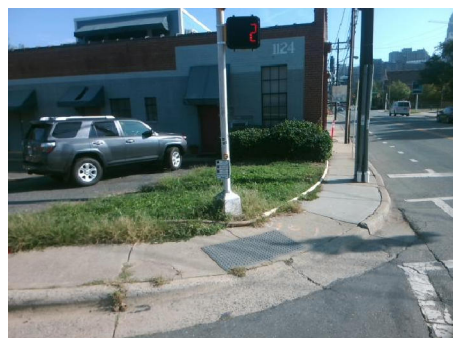
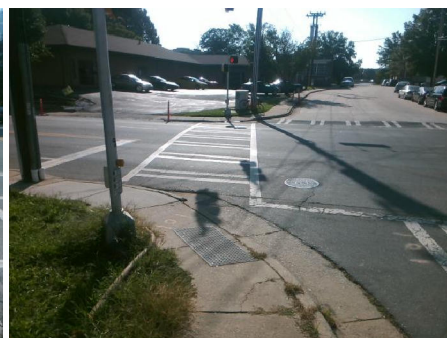
**Not Found, R304.2.2, R304.5.3**

Compliance	Description	Data	Compliance	Description	Data
N/A	Ramp Length (in)	48.0	No	Ramp Slope (%)	13.2
Yes	Ramp Width (in)	48.0	No	Ramp XSlope (%)	5.8
N/A	Flare Type LT	N/A	N/A	Flare Type RT	N/A
N/A	Flare Slope LT (%)	N/A	N/A	Flare Slope RT (%)	N/A
N/A	Flare Traversable LT?	N/A	N/A	Flare Traversable RT?	N/A
N/A	Landing Length (in)	N/A	N/A	DWS Provided?	N/A
N/A	Landing Width (in)	N/A	N/A	DWS Contrast?	N/A
N/A	Landing Slope (%)	N/A	N/A	DWS Length (in)	N/A
N/A	Landing X Slope (%)	N/A	N/A	DWS Full Width?	N/A
N/A	Landing Curb? (Y/N)	N/A	N/A	DWS Offset (in)	N/A
N/A	Shared Landing?	N/A			
N/A	Gutter Ponding?	N/A	N/A	Gutter Slope (%)	N/A
N/A	Gutter Lip Ht (in)	N/A	N/A	Gutter X Slope (%)	N/A
N/A	Painted X Walk1?	Yes	N/A	Painted X Walk2?	Yes
	X Walk 1 Direction	To SW		X Walk 2 Direction	To SE
N/A	X Walk 1 Width (in)	114.0	N/A	X Walk 2 Width (in)	108.0
	X Walk 1 Slope (%)	4.0		X Walk 2 Slope (%)	2.6
	X Walk 1 X Slope (%)	2.5		X Walk 2 X Slope (%)	4.2

N/A	Ramp inside XWalk1?	Yes	N/A	Ramp inside XWalk2?	Yes
	Road Slope (%)	4.0	N/A	Clear Space?	N/A
	Road X Slope (%)	3.4	N/A	Clear Space to XWalk (in)	N/A
N/A	Any Obstructions?	N/A	N/A	Storm Grate/Utility Hazard?	N/A
	Obstruction Type			Storm Grate/Utility Type	
		N/A			N/A
		Yes		Surface Condition? (G/P)	Good

**Remove & Replace Curb Ramp With Two New Directional Ramps or Equivalent.**

Total Cost: \$ 3200.00
