Access Compliance Report

Public Rights-of-Way

(Curb Ramps)

Intersection ID: 6594	Main Street: DALE_AV	Cross Street: ROOK_RD	Location:	N
ADA ID: 111972D7A95F	Ramp Type: PerpDiag	Initial Pass/Fail: Fail	Overall Compliance: No	Severity Score: 37.5
Codes/Mitigation Info/Possible Solution		Field Measurements/Component Compliance

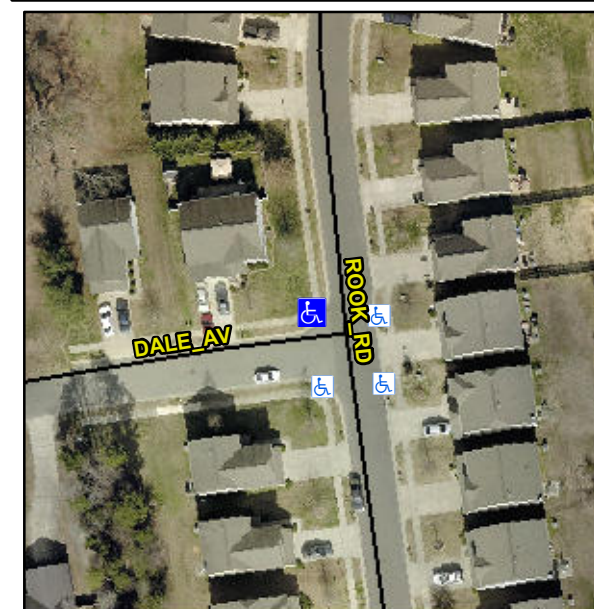
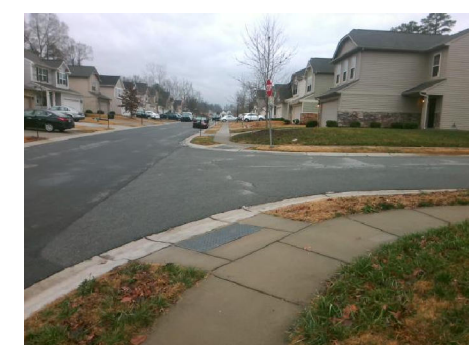
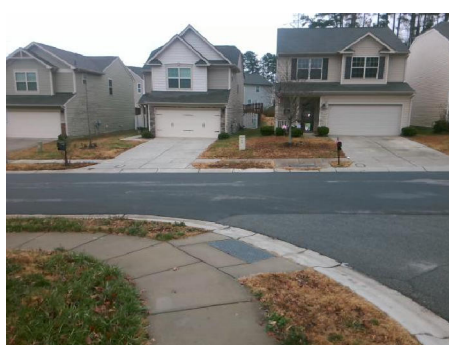
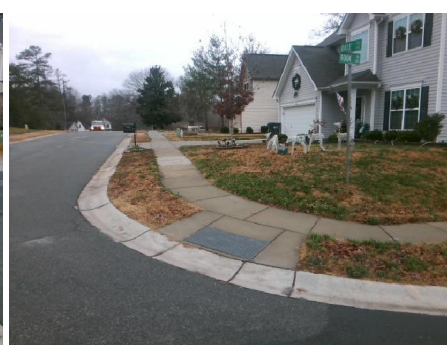
Not Found, R304.2.2, R304.5.3

Compliance	Description	Data	Compliance	Description	Data
N/A	Ramp Length (in)	49.0	No	Ramp Slope (%)	10.0
Yes	Ramp Width (in)	48.0	No	Ramp XSlope (%)	8.6
N/A	Flare Type LT	N/A	N/A	Flare Type RT	N/A
N/A	Flare Slope LT (%)	N/A	N/A	Flare Slope RT (%)	N/A
N/A	Flare Traversable LT?	N/A	N/A	Flare Traversable RT?	N/A
N/A	Landing Length (in)	N/A	N/A	DWS Provided?	N/A
N/A	Landing Width (in)	N/A	N/A	DWS Contrast?	N/A
N/A	Landing Slope (%)	N/A	N/A	DWS Length (in)	N/A
N/A	Landing X Slope (%)	N/A	N/A	DWS Full Width?	N/A
N/A	Landing Curb? (Y/N)	N/A	N/A	DWS Offset (in)	N/A
N/A	Shared Landing?	N/A			
N/A	Gutter Ponding?	N/A	N/A	Gutter Slope (%)	N/A
N/A	Gutter Lip Ht (in)	N/A	N/A	Gutter X Slope (%)	N/A
N/A	Painted X Walk1?	No	N/A	Painted X Walk2?	No
	X Walk 1 Direction	To W		X Walk 2 Direction	To S
N/A	X Walk 1 Width (in)	N/A	N/A	X Walk 2 Width (in)	N/A
	X Walk 1 Slope (%)	4.2		X Walk 2 Slope (%)	1.7
	X Walk 1 X Slope (%)	3.1		X Walk 2 X Slope (%)	4.5

N/A	Ramp inside XWalk1?	N/A	N/A	Ramp inside XWalk2?	N/A
	Road Slope (%)	5.1	N/A	Clear Space?	N/A
	Road X Slope (%)	4.0	N/A	Clear Space to XWalk (in)	N/A
N/A	Any Obstructions?	N/A	N/A	Storm Grate/Utility Hazard?	N/A
	Obstruction Type			Storm Grate/Utility Type	
		N/A			N/A
		Yes		Surface Condition? (G/P)	Good

Remove & Replace Curb Ramp With Two New Directional Ramps or Equivalent.

Total Cost: \$ 3200.00
