Access Compliance Report

Public Rights-of-Way

(Curb Ramps)

Intersection ID: 22882	Main Street: SARDIS_POINTE_RD	Cross Street: SARDIS_RD	Location: SW
ADA ID: 111ACBE46DAD	Ramp Type: Perp	Initial Pass/Fail: Fail	Overall Compliance: No
Severity Score: 33.75			
Codes/Mitigation Info/Possible Solution		Field Measurements/Component Compliance

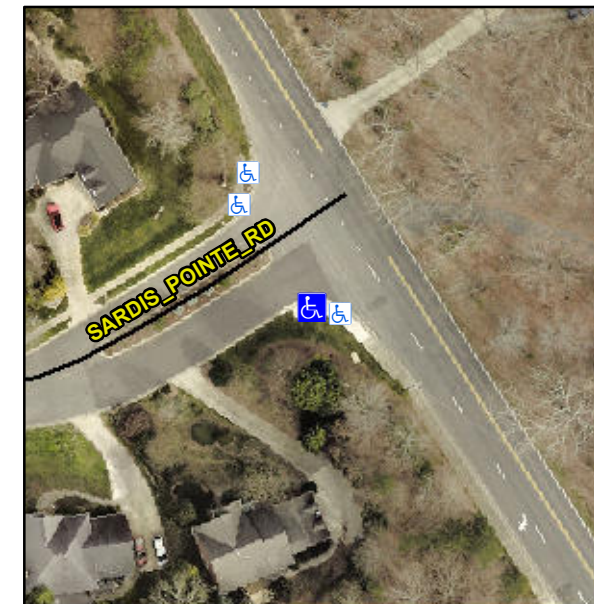
Not Found, R304.5.1, R304.5.3

Compliance	Description	Data	Compliance	Description	Data
N/A	Ramp Length (in)	71.5	Yes	Ramp Slope (%)	6.2
No	Ramp Width (in)	46.5	No	Ramp XSlope (%)	11.8
N/A	Flare Type LT	N/A	N/A	Flare Type RT	N/A
N/A	Flare Slope LT (%)	N/A	N/A	Flare Slope RT (%)	N/A
N/A	Flare Traversable LT?	N/A	N/A	Flare Traversable RT?	N/A
N/A	Landing Length (in)	N/A	N/A	DWS Provided?	N/A
N/A	Landing Width (in)	N/A	N/A	DWS Contrast?	N/A
N/A	Landing Slope (%)	N/A	N/A	DWS Length (in)	N/A
N/A	Landing X Slope (%)	N/A	N/A	DWS Full Width?	N/A
N/A	Landing Curb? (Y/N)	N/A	N/A	DWS Offset (in)	N/A
N/A	Shared Landing?	N/A			
N/A	Gutter Ponding?	N/A	N/A	Gutter Slope (%)	N/A
N/A	Gutter Lip Ht (in)	N/A	N/A	Gutter X Slope (%)	N/A
N/A	Painted X Walk1?	No	N/A	Painted X Walk2?	N/A
	X Walk 1 Direction	To NW		X Walk 2 Direction	N/A
N/A	X Walk 1 Width (in)	N/A	N/A	X Walk 2 Width (in)	N/A
	X Walk 1 Slope (%)	0.6		X Walk 2 Slope (%)	N/A
	X Walk 1 X Slope (%)	8.6		X Walk 2 X Slope (%)	N/A

Possible Solutions:

Remove & Replace Entire Ramp.

Total Cost: \$ 1850.00
