# Access Compliance Report

## Public Rights-of-Way

### (Curb Ramps)

| Intersection ID: 8541 | Main Street: DARBY_AV | Cross Street: HONEYWOOD_AV | Location: SW |

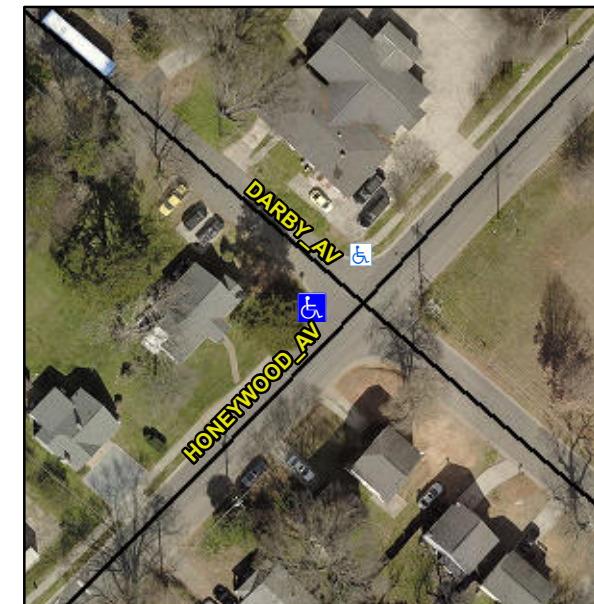
**OVHD VEG OBS**

**Not Found, R304.5.1**

| Compliance | Description | Data | Compliance | Description | Data |
|---|---|---|---|---|---|
| No | Ramp Width (in) | 47.0 | Yes | BlendTrans XSlope (%) | 1.9 |
| | | | No | Curb Slope (%) | 17.2 |

**Remove & Replace Curb Ramp With Two New Directional Ramps or Equivalent.**
