Access Compliance Report

Public Rights-of-Way

(Curb Ramps)

Intersection ID: 12695	Main Street: S_CALDWELL_ST	Cross Street: E TRADE ST	Location:	W
ADA ID: 111D27AC2F5F	Ramp Type: Perp	Initial Pass/Fail: Fail	Overall Compliance: No	Severity Score: 25

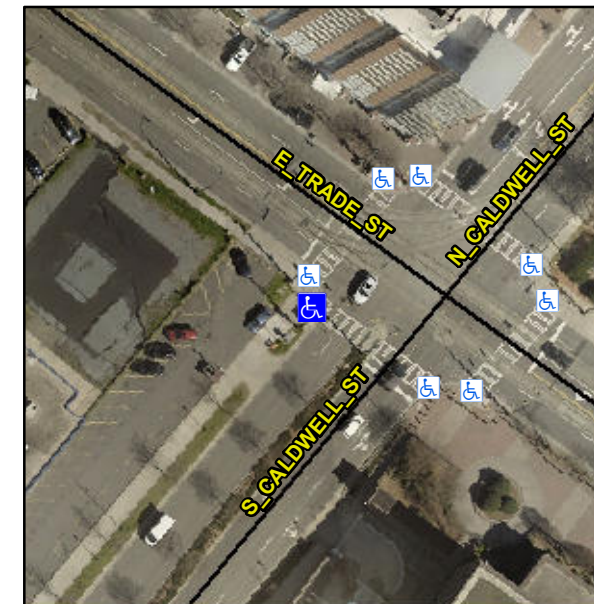
Not Found, R304.5.3

Compliance	Description	Data	Compliance	Description	Data
N/A	Ramp Length (in)	80.0	Yes	Ramp Slope (%)	6.1
Yes	Ramp Width (in)	48.0	No	Ramp XSlope (%)	7.9
N/A	Flare Type LT	N/A	N/A	Flare Type RT	N/A
N/A	Flare Slope LT (%)	N/A	N/A	Flare Slope RT (%)	N/A
N/A	Flare Traversable LT?	N/A	N/A	Flare Traversable RT?	N/A
N/A	Landing Length (in)	N/A	N/A	DWS Provided?	N/A
N/A	Landing Width (in)	N/A	N/A	DWS Contrast?	N/A
N/A	Landing Slope (%)	N/A	N/A	DWS Length (in)	N/A
N/A	Landing X Slope (%)	N/A	N/A	DWS Full Width?	N/A
N/A	Landing Curb? (Y/N)	N/A	N/A	DWS Offset (in)	N/A
N/A	Shared Landing?	N/A			
N/A	Gutter Ponding?	N/A	N/A	Gutter Slope (%)	N/A
N/A	Gutter Lip Ht (in)	N/A	N/A	Gutter X Slope (%)	N/A
N/A	Painted X Walk1?	Yes	N/A	Painted X Walk2?	N/A
	X Walk 1 Direction	To SE		X Walk 2 Direction	N/A
N/A	X Walk 1 Width (in)	112.0	N/A	X Walk 2 Width (in)	N/A
	X Walk 1 Slope (%)	1.3		X Walk 2 Slope (%)	N/A
	X Walk 1 X Slope (%)	0.3		X Walk 2 X Slope (%)	N/A

Remove & Replace Entire Ramp.
