Access Compliance Report

Public Rights-of-Way

(Curb Ramps)

Intersection ID: 43841	Main Street: DELUCA_DR	Cross Street: TAGGERT_CT	Location: SW
ADA ID: 112BA1A58E61	Ramp Type: PerpDiag	Initial Pass/Fail: Fail	Overall Compliance: No
Severity Score: 10			
Codes/Mitigation Info/Possible Solution		Field Measurements/Component Compliance

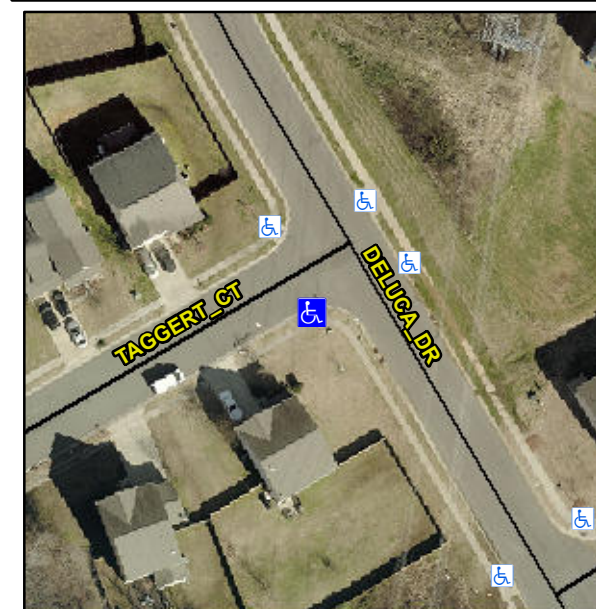
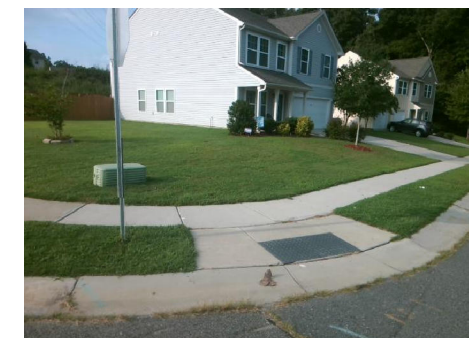
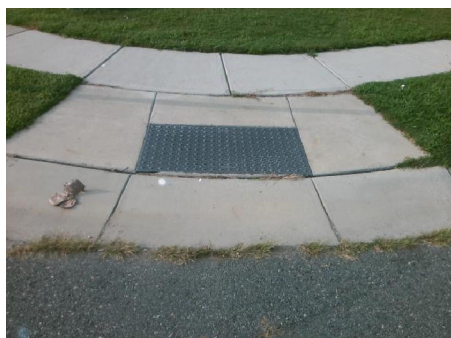
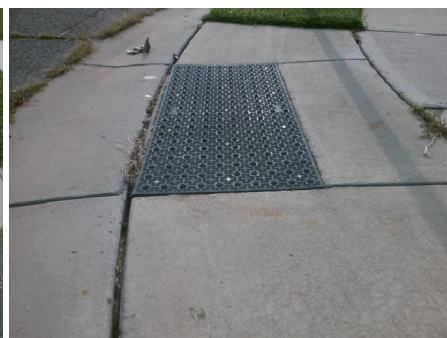
Not Found, R304.5.1, R304.5.3

Compliance	Description	Data	Compliance	Description	Data
N/A	Ramp Length (in)	45.5	Yes	Ramp Slope (%)	6.6
No	Ramp Width (in)	47.5	No	Ramp XSlope (%)	3.2
N/A	Flare Type LT	N/A	N/A	Flare Type RT	N/A
N/A	Flare Slope LT (%)	N/A	N/A	Flare Slope RT (%)	N/A
N/A	Flare Traversable LT?	N/A	N/A	Flare Traversable RT?	N/A
N/A	Landing Length (in)	N/A	N/A	DWS Provided?	N/A
N/A	Landing Width (in)	N/A	N/A	DWS Contrast?	N/A
N/A	Landing Slope (%)	N/A	N/A	DWS Length (in)	N/A
N/A	Landing X Slope (%)	N/A	N/A	DWS Full Width?	N/A
N/A	Landing Curb? (Y/N)	N/A	N/A	DWS Offset (in)	N/A
N/A	Shared Landing?	N/A			
N/A	Gutter Ponding?	N/A	N/A	Gutter Slope (%)	N/A
N/A	Gutter Lip Ht (in)	N/A	N/A	Gutter X Slope (%)	N/A
N/A	Painted X Walk1?	No	N/A	Painted X Walk2?	No
	X Walk 1 Direction	To E		X Walk 2 Direction	To N
N/A	X Walk 1 Width (in)	N/A	N/A	X Walk 2 Width (in)	N/A
	X Walk 1 Slope (%)	3.3		X Walk 2 Slope (%)	0.2
	X Walk 1 X Slope (%)	3.1		X Walk 2 X Slope (%)	1.5

N/A	Ramp inside XWalk1?	N/A	N/A	Ramp inside XWalk2?	N/A
	Road Slope (%)	1.0	N/A	Clear Space?	N/A
	Road X Slope (%)	4.6	N/A	Clear Space to XWalk (in)	N/A
N/A	Any Obstructions?	N/A	N/A	Storm Grate/Utility Hazard?	N/A
	Obstruction Type			Storm Grate/Utility Type	
		N/A			N/A
			Yes	Surface Condition? (G/P)	Good

Remove & Replace Curb Ramp With Two New Directional Ramps or Equivalent.
