Access Compliance Report

Public Rights-of-Way

(Curb Ramps)

Intersection ID: N/A	Main Street: ROUNDING_RUN_LN	Cross Street: WOODFOX_DR	Location: SW
ADA ID: 11399AEC1AD0	Ramp Type: BlendTrans2	Initial Pass/Fail: Fail	Overall Compliance: No
		Severity Score: 12.5

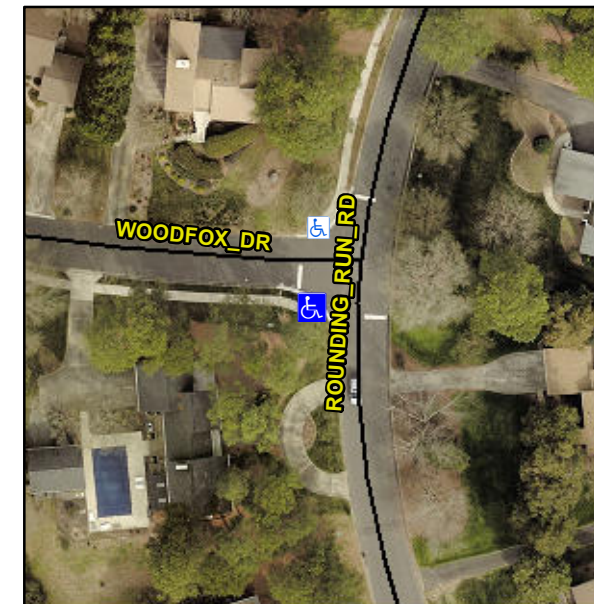
Compliance	Description	Data	Compliance	Description	Data
N/A	Ramp Length (in)	106.0	Yes	BlendTrans Slope (%)	1.1
Yes	Ramp Width (in)	58.0	No	BlendTrans XSlope (%)	6.0
N/A	Flare Type LT	N/A	N/A	Flare Type RT	N/A
N/A	Flare Slope LT (%)	N/A	N/A	Flare Slope RT (%)	N/A
N/A	Flare Traversable LT?	N/A	N/A	Flare Traversable RT?	N/A
N/A	Landing Length (in)	N/A	N/A	DWS Provided?	N/A
N/A	Landing Width (in)	N/A	N/A	DWS Contrast?	N/A
N/A	Landing Slope (%)	N/A	N/A	DWS Length (in)	N/A
N/A	Landing X Slope (%)	N/A	N/A	DWS Full Width?	N/A
N/A	Landing Curb? (Y/N)	N/A	N/A	DWS Offset (in)	N/A
N/A	Shared Landing?	N/A			
N/A	Gutter Ponding?	N/A	N/A	Gutter Slope (%)	N/A
N/A	Gutter Lip Ht (in)	N/A	N/A	Gutter X Slope (%)	N/A
N/A	Painted X Walk1?	No	N/A	Painted X Walk2?	No
	X Walk 1 Direction	To E		X Walk 2 Direction	To N
	X Walk 1 Width (in)	N/A		X Walk 2 Width (in)	N/A
	X Walk 1 Slope (%)	8.1		X Walk 2 Slope (%)	1.2
	X Walk 1 X Slope (%)	2.2		X Walk 2 X Slope (%)	8.1

Remove & Replace Curb Ramp With Two New Directional Ramps or Equivalent.
