Access Compliance Report

Public Rights-of-Way

(Curb Ramps)

Intersection ID: 10640	Main Street: MARTIN_ST	Cross Street: WAKE_ST	Location: E
ADA ID: 113CCFB09F1D	Ramp Type: Perp	Initial Pass/Fail: Fail	Overall Compliance: No
Severity Score: 33.75			
Codes/Mitigation Info/Possible Solution		Field Measurements/Component Compliance

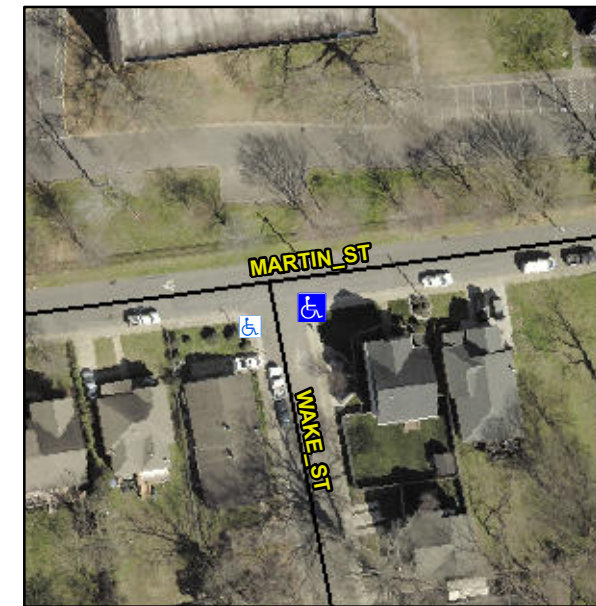
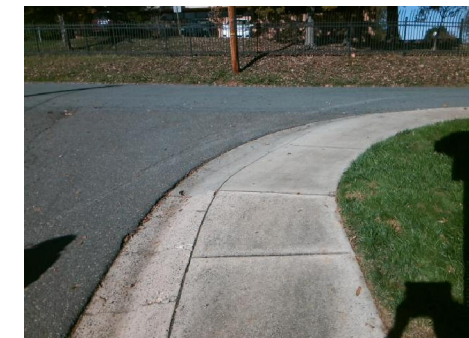
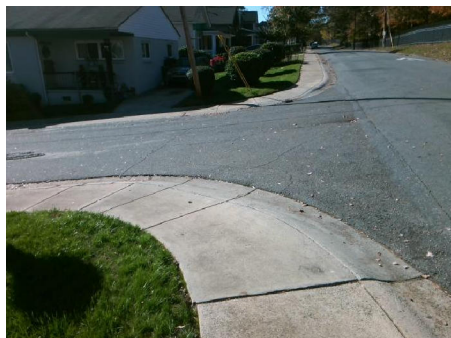
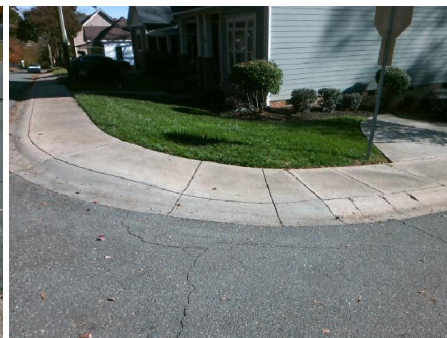
Not Found, R304.5.1, R304.5.3

Compliance	Description	Data	Compliance	Description	Data
N/A	Ramp Length (in)	48.0	Yes	Ramp Slope (%)	5.5
No	Ramp Width (in)	39.0	No	Ramp XSlope (%)	10.1
N/A	Flare Type LT	N/A	N/A	Flare Type RT	N/A
N/A	Flare Slope LT (%)	N/A	N/A	Flare Slope RT (%)	N/A
N/A	Flare Traversable LT?	N/A	N/A	Flare Traversable RT?	N/A
N/A	Landing Length (in)	N/A	N/A	DWS Provided?	N/A
N/A	Landing Width (in)	N/A	N/A	DWS Contrast?	N/A
N/A	Landing Slope (%)	N/A	N/A	DWS Length (in)	N/A
N/A	Landing X Slope (%)	N/A	N/A	DWS Full Width?	N/A
N/A	Landing Curb? (Y/N)	N/A	N/A	DWS Offset (in)	N/A
N/A	Shared Landing?	N/A			
N/A	Gutter Ponding?	N/A	N/A	Gutter Slope (%)	N/A
N/A	Gutter Lip Ht (in)	0.5	N/A	Gutter X Slope (%)	N/A
N/A	Painted X Walk1?	No	N/A	Painted X Walk2?	N/A
	X Walk 1 Direction	To W		X Walk 2 Direction	N/A
N/A	X Walk 1 Width (in)	N/A	N/A	X Walk 2 Width (in)	N/A
	X Walk 1 Slope (%)	4.4		X Walk 2 Slope (%)	N/A
	X Walk 1 X Slope (%)	12.6		X Walk 2 X Slope (%)	N/A

N/A	Ramp inside XWalk1?	N/A	N/A	Ramp inside XWalk2?	N/A
	Road Slope (%)	N/A	N/A	Clear Space?	N/A
	Road X Slope (%)	N/A	N/A	Clear Space to XWalk (in)	N/A
N/A	Any Obstructions?	N/A	N/A	Storm Grate/Utility Hazard?	N/A
	Obstruction Type			Storm Grate/Utility Type	
		N/A			N/A
			Yes	Surface Condition? (G/P)	Good

Remove & Replace Entire Ramp.
