Access Compliance Report

Public Rights-of-Way

(Curb Ramps)

Intersection ID: N/A	Main Street: 7TH_ST	Cross Street: PECAN_AV	Location: N
ADA ID: 113D4C9E318A	Ramp Type: Perp	Initial Pass/Fail: Fail	Overall Compliance: No
			Severity Score: 13.75

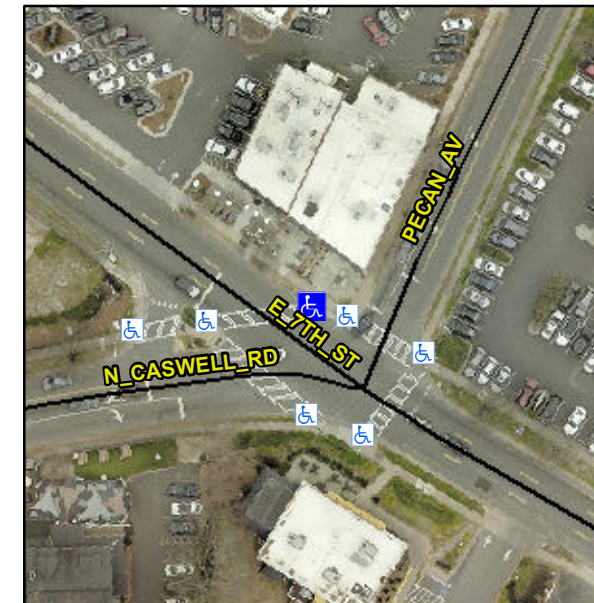
Not Found, R304.2.2, R304.5.3

Compliance	Description	Data	Compliance	Description	Data
N/A	Ramp Length (in)	48.0	No	Ramp Slope (%)	9.1
Yes	Ramp Width (in)	48.0	No	Ramp XSlope (%)	2.2
N/A	Flare Type LT	N/A	N/A	Flare Type RT	N/A
N/A	Flare Slope LT (%)	N/A	N/A	Flare Slope RT (%)	N/A
N/A	Flare Traversable LT?	N/A	N/A	Flare Traversable RT?	N/A
N/A	Landing Length (in)	N/A	N/A	DWS Provided?	N/A
N/A	Landing Width (in)	N/A	N/A	DWS Contrast?	N/A
N/A	Landing Slope (%)	N/A	N/A	DWS Length (in)	N/A
N/A	Landing X Slope (%)	N/A	N/A	DWS Full Width?	N/A
N/A	Landing Curb? (Y/N)	N/A	N/A	DWS Offset (in)	N/A
N/A	Shared Landing?	N/A			
N/A	Gutter Ponding?	N/A	N/A	Gutter Slope (%)	N/A
N/A	Gutter Lip Ht (in)	1.0	N/A	Gutter X Slope (%)	N/A
N/A	Painted X Walk1?	Yes	N/A	Painted X Walk2?	N/A
	X Walk 1 Direction	To W		X Walk 2 Direction	N/A
N/A	X Walk 1 Width (in)	120.0	N/A	X Walk 2 Width (in)	N/A
	X Walk 1 Slope (%)	3.4		X Walk 2 Slope (%)	N/A
	X Walk 1 X Slope (%)	1.8		X Walk 2 X Slope (%)	N/A

N/A	Ramp inside XWalk1?	Yes	N/A	Ramp inside XWalk2?	N/A
	Road Slope (%)	N/A	N/A	Clear Space?	N/A
	Road X Slope (%)	N/A	N/A	Clear Space to XWalk (in)	N/A
N/A	Any Obstructions?	N/A	N/A	Storm Grate/Utility Hazard?	N/A
	Obstruction Type			Storm Grate/Utility Type	
		N/A			N/A
			Yes	Surface Condition? (G/P)	Good

Remove & Replace Entire Ramp.
