Access Compliance Report

Public Rights-of-Way

(Curb Ramps)

Intersection ID: 16141	Main Street: N_WENDOVER_RD	Cross Street: LATROBE_DR	Location:	SW
ADA ID: 113DF45D75A2	Ramp Type: Perp	Initial Pass/Fail: Fail	Overall Compliance: No	Severity Score: 12.5

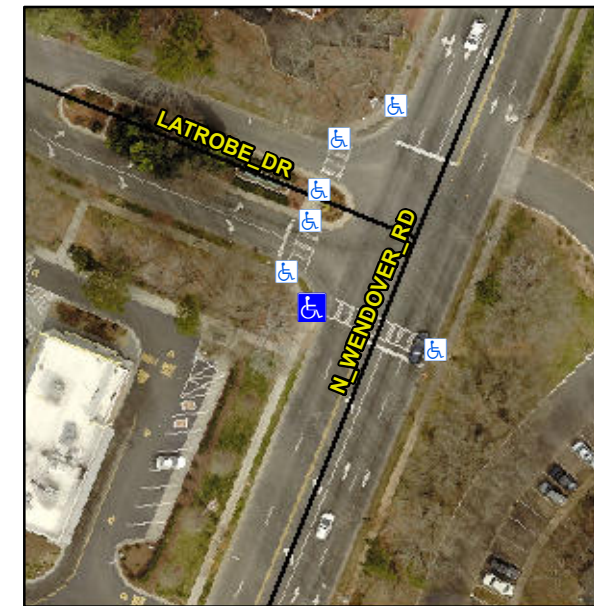
Not Found, R304.2.2

Compliance	Description	Data	Compliance	Description	Data
N/A	Ramp Length (in)	58.0	No	Ramp Slope (%)	8.9
Yes	Ramp Width (in)	48.0	Yes	Ramp XSlope (%)	1.7
N/A	Flare Type LT	N/A	N/A	Flare Type RT	N/A
N/A	Flare Slope LT (%)	N/A	N/A	Flare Slope RT (%)	N/A
N/A	Flare Traversable LT?	N/A	N/A	Flare Traversable RT?	N/A
N/A	Landing Length (in)	N/A	N/A	DWS Provided?	N/A
N/A	Landing Width (in)	N/A	N/A	DWS Contrast?	N/A
N/A	Landing Slope (%)	N/A	N/A	DWS Length (in)	N/A
N/A	Landing X Slope (%)	N/A	N/A	DWS Full Width?	N/A
N/A	Landing Curb? (Y/N)	N/A	N/A	DWS Offset (in)	N/A
N/A	Shared Landing?	N/A			
N/A	Gutter Ponding?	N/A	N/A	Gutter Slope (%)	N/A
N/A	Gutter Lip Ht (in)	N/A	N/A	Gutter X Slope (%)	N/A
N/A	Painted X Walk1?	Yes	N/A	Painted X Walk2?	N/A
	X Walk 1 Direction	To SE		X Walk 2 Direction	N/A
N/A	X Walk 1 Width (in)	104.0	N/A	X Walk 2 Width (in)	N/A
	X Walk 1 Slope (%)	3.7		X Walk 2 Slope (%)	N/A
	X Walk 1 X Slope (%)	3.7		X Walk 2 X Slope (%)	N/A

Remove & Replace Entire Ramp.
