# Access Compliance Report

## Public Rights-of-Way

### (Curb Ramps)

| Intersection ID: 48581 | Main Street: WATERLILY_LN | Cross Street: RUMPLE_RD | Location: NE |

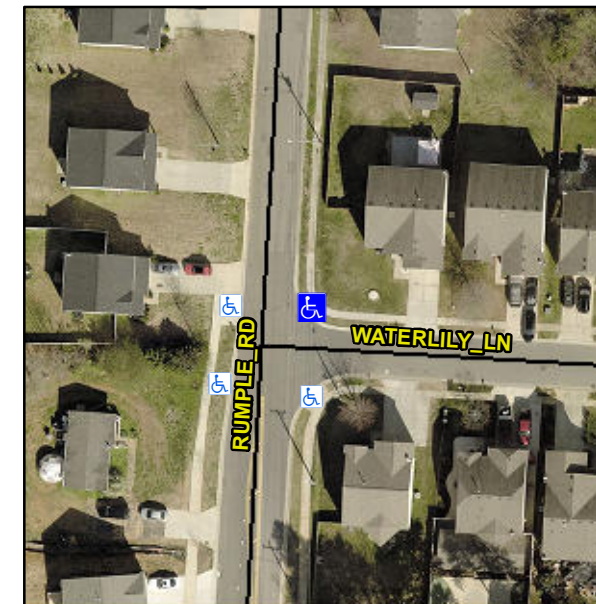
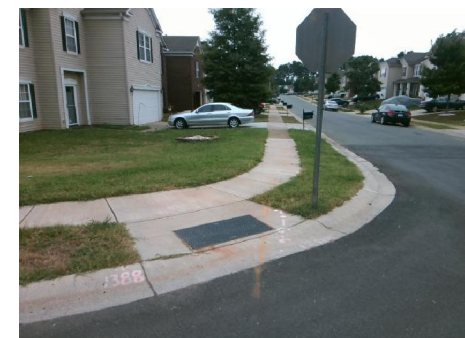
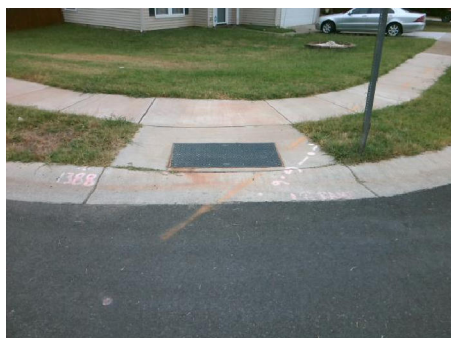
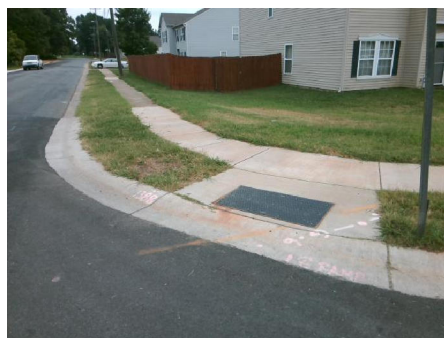
| ADA ID: 113F34143821 | Ramp Type: BlendTrans1 | Initial Pass/Fail: Fail | Overall Compliance: No |
| | | Severity Score: 8.75 | |

**Not Found, R304.5.1**

| Compliance | Description | Data | Compliance | Description | Data |
|---|---|---|---|---|---|
| N/A | Ramp Length (in) | 47.0 | Yes | BlendTrans Slope (%) | 3.6 |
| No | Ramp Width (in) | 47.0 | Yes | BlendTrans XSlope (%) | 1.2 |
| | | | No | Curb Slope (%) | 10.3 |

**Remove & Replace Curb Ramp With Two New Directional Ramps or Equivalent.**

Total Cost: \$ 3200.00
