Access Compliance Report

Public Rights-of-Way

(Curb Ramps)

Intersection ID: 10040250	Main Street: VAIL_AV	Cross Street: N/A	Location: N
ADA ID: 11401D81E6A2	Ramp Type: Directional1	Initial Pass/Fail: Fail	Overall Compliance: No
			Severity Score: 26.25

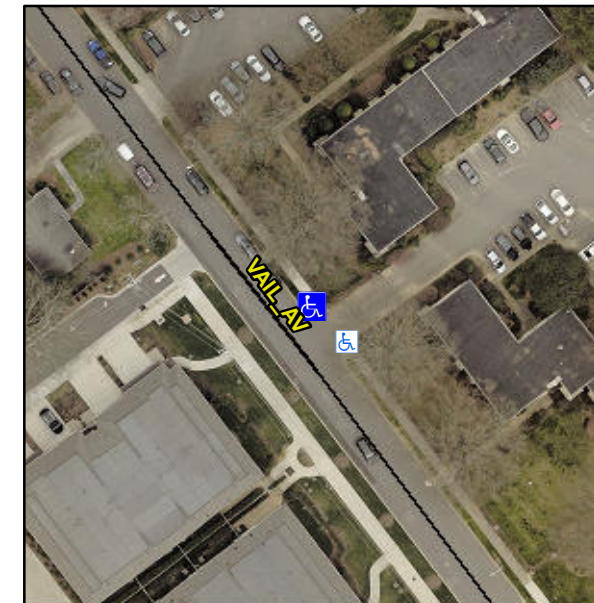
R304.2.2, R304.5.3

Compliance	Description	Data	Compliance	Description	Data
N/A	Ramp Length (in)	97.0	N/A	Grade Break?	N/A
Yes	Ramp Width (in)	67.0	N/A	Grade Break Slope (%)	0.0
No	Ramp Slope (%)	12.1	N/A	Grade Break XSlope (%)	0.0
No	Ramp XSlope (%)	4.3			
N/A	Flare Type LT	N/A	N/A	Flare Type RT	N/A
N/A	Flare Slope LT (%)	N/A	N/A	Flare Slope RT (%)	0.0
N/A	Flare Traversable LT?	N/A	N/A	Flare Traversable RT?	N/A
N/A	Landing Length (in)	0.0	N/A	DWS Provided?	N/A
N/A	Landing Width (in)	0.0	N/A	DWS Contrast?	N/A
N/A	Landing Slope (%)	0.0	N/A	DWS Length (in)	N/A
N/A	Landing X Slope (%)	0.0	N/A	DWS Full Width?	N/A
N/A	Landing Curb? (Y/N)	N/A	N/A	DWS Offset LT (in)	N/A
N/A	Shared Landing?	N/A	N/A	DWS Offset RT (in)	N/A
N/A	Gutter Ponding?	0.0	N/A	Gutter Slope (%)	N/A
N/A	Gutter Lip Ht (in)	0.0	N/A	Gutter X Slope (%)	N/A
N/A	Painted X Walk1?	No		Road Slope (%)	0.4
	X Walk 1 Direction	To SE		Road X Slope (%)	0.4
	X Walk 1 Width (in)	N/A		Clear Space?	N/A

X Walk 1 Slope (%)	0.4	N/A	Clear Space to XWalk (in)	N/A
	X Walk 1 X Slope (%)	0.4	N/A	Storm Grate/Utility Hazard?	N/A
N/A	Ramp inside XWalk1?	N/A		Storm Grate/Utility Type	
N/A	Any Obstructions?	N/A			N/A
	Obstruction Type		Yes	Surface Condition? (G/P)	Good
			N/A	Curb Slope (%)	17.6

Remove & Replace Entire Ramp.
