## Access Compliance Report Public Rights-of-Way (Curb Ramps)

Intersection ID: 19210	Main Street: TYVOLA_RD			Cross Street: FARMBROOK_DR				Location:	NW
ADA ID: 1147223B113B	Ramp Type: Perp			Initial Pass/Fail: Fail Overall Compliance: No				o Severity Score:	8.75
Codes/Mitigation Info/Possible Solution				Field Measurements/Component Compliance					
	「三日」	Possible Solutions:		Compliance Description			Data Compliance Description		
ALL	A State	Remove & Replace Entire Ramp	).	N/A	Ramp Length (in)	60.0	Yes	Ramp Slope (%)	5.6
A A A A A A A A A A A A A A A A A A A				No	Ramp Width (in)	36.0	Yes	Ramp XSlope (%)	1.2
A CARLER AND A CAR	the state			N/A	Flare Type LT	N/A	N/A	Flare Type RT	N/A
And the state of the	-16.391			N/A	Flare Slope LT (%)	N/A	N/A	Flare Slope RT (%)	N/A
the all the second	They Prove			N/A	Flare Traversable LT?	N/A	N/A	Flare Traversable RT?	N/A
and the second second	CALLAN AN			N/A	Landing Length (in)	N/A	N/A	DWS Provided?	N/A
The state of the s		Surveyor Notes:		N/A	Landing Width (in)	N/A	N/A	DWS Contrast?	N/A

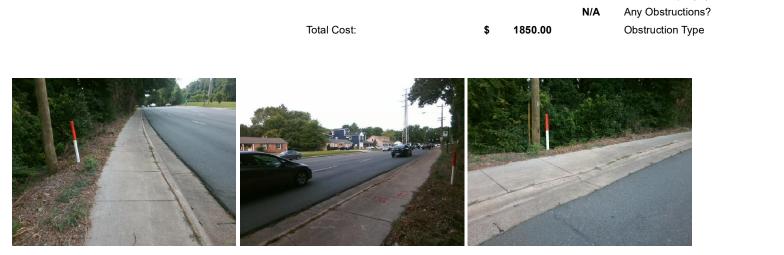
-	Not Found, R304.5.1		N/A	Gutter Lip Ht (in)	N/A	N/A	Gutter X Slope (%)	N/A
	1000	, i i i i i i i i i i i i i i i i i i i		N/A	Painted X Walk1?	No	N/A	Painted X Walk2?	N/A
S Blance /					X Walk 1 Direction	To S		X Walk 2 Direction	N/A
				N/A	X Walk 1 Width (in)	N/A	N/A	X Walk 2 Width (in)	N/A
Street 1 Name	TYVOLA RD				X Walk 1 Slope (%)	1.2		X Walk 2 Slope (%)	N/A
Stop Condition-Street 2	None				X Walk 1 X Slope (%)	1.8		X Walk 2 X Slope (%)	N/A
Street 2 Name	N/A			N/A	Ramp inside XWalk1?	N/A	N/A	Ramp inside XWalk2?	N/A
Stop Condition-Street 1	N/A				Road Slope (%)	N/A	N/A	Clear Space?	N/A
					Road X Slope (%)	N/A	N/A	Clear Space to XWalk (in)	N/A
				N/A	Any Obstructions?	N/A	N/A	Storm Grate/Utility Hazard?	N/A
		Total Cost: \$	1850.00		Obstruction Type			Storm Grate/Utility Type	
						N/A			N/A
