# Access Compliance Report

## Public Rights-of-Way

### (Curb Ramps)

| Intersection ID: 45494 | Main Street: BUGGY_HORSE_RD | Cross Street: COTTON_STAND_RD | Location: S |

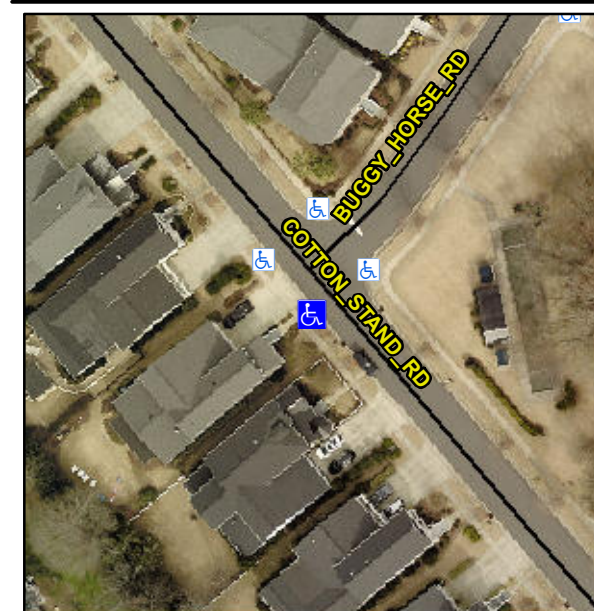
| ADA ID: 115B30F23FB3 | Ramp Type: Perp | Initial Pass/Fail: Pass | Overall Compliance: No |
| Severity Score: 5.25 | | | |

**Not Found, R304.2.2-Perp, R304.3.2-Para, R304.5.4, R304.5.3**

| Compliance | Description | Data | Compliance | Description | Data |
|---|---|---|---|---|---|
| No | Landing Slope (%) | 2.9 | Yes | DWS Length (in) | 24.5 |
| Yes | Gutter Ponding? | No | No | Gutter Slope (%) | 13.1 |
| Yes | Gutter Lip Ht (in) | 0.0 | No | Gutter X Slope (%) | 2.8 |

**Remove & Replace Entire Ramp.  
Remove & Replace Gutter.**

Total Cost: \$ 2600.00
