# Access Compliance Report

## Public Rights-of-Way

### (Curb Ramps)

Intersection ID: 14036	Main Street: COMMONWEALTH_AV	Cross Street: MORNINGSIDE_DR	Location:	N
ADA ID: 11608AFB93F1	Ramp Type: Perp	Initial Pass/Fail: Fail	Overall Compliance: No	Severity Score: 13.75
Codes/Mitigation Info/Possible Solution		Field Measurements/Component Compliance

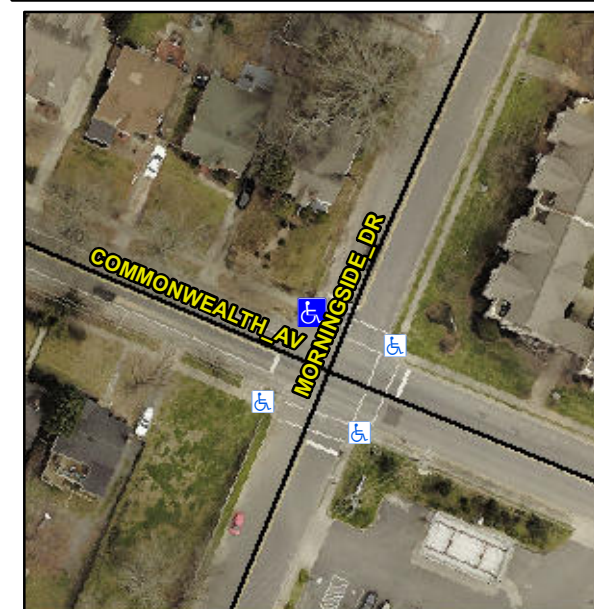
**Not Found, R304.2.2, R304.5.3**

Compliance	Description	Data	Compliance	Description	Data
N/A	Ramp Length (in)	77.0	No	Ramp Slope (%)	10.5
Yes	Ramp Width (in)	48.0	No	Ramp XSlope (%)	2.7
N/A	Flare Type LT	N/A	N/A	Flare Type RT	N/A
N/A	Flare Slope LT (%)	N/A	N/A	Flare Slope RT (%)	N/A
N/A	Flare Traversable LT?	N/A	N/A	Flare Traversable RT?	N/A
N/A	Landing Length (in)	N/A	N/A	DWS Provided?	N/A
N/A	Landing Width (in)	N/A	N/A	DWS Contrast?	N/A
N/A	Landing Slope (%)	N/A	N/A	DWS Length (in)	N/A
N/A	Landing X Slope (%)	N/A	N/A	DWS Full Width?	N/A
N/A	Landing Curb? (Y/N)	N/A	N/A	DWS Offset (in)	N/A
N/A	Shared Landing?	N/A			
N/A	Gutter Ponding?	N/A	N/A	Gutter Slope (%)	N/A
N/A	Gutter Lip Ht (in)	N/A	N/A	Gutter X Slope (%)	N/A
N/A	Painted X Walk1?	Yes	N/A	Painted X Walk2?	N/A
	X Walk 1 Direction	To SE		X Walk 2 Direction	N/A
N/A	X Walk 1 Width (in)	117.0	N/A	X Walk 2 Width (in)	N/A
	X Walk 1 Slope (%)	2.7		X Walk 2 Slope (%)	N/A
	X Walk 1 X Slope (%)	0.2		X Walk 2 X Slope (%)	N/A

N/A	Ramp inside XWalk1?	Yes	N/A	Ramp inside XWalk2?	N/A
	Road Slope (%)	N/A	N/A	Clear Space?	N/A
	Road X Slope (%)	N/A	N/A	Clear Space to XWalk (in)	N/A
N/A	Any Obstructions?	N/A	N/A	Storm Grate/Utility Hazard?	N/A
	Obstruction Type			Storm Grate/Utility Type	
		N/A			N/A
			Yes	Surface Condition? (G/P)	Good

**Remove & Replace Entire Ramp.**

Total Cost: \$ 1850.00
