# Access Compliance Report

## Public Rights-of-Way

### (Curb Ramps)

Intersection ID: 50517	Main Street: STEWART TERRACE_WY	Cross Street: MICHAEL CROSSING_DR	Location: NE
ADA ID: 116A3604691F	Ramp Type: PerpDiag	Initial Pass/Fail: Fail	Overall Compliance: No
Severity Score: 12.5			
Codes/Mitigation Info/Possible Solution		Field Measurements/Component Compliance

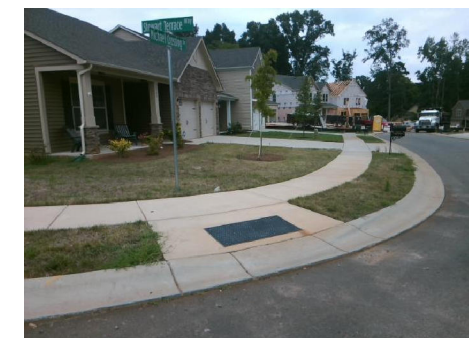
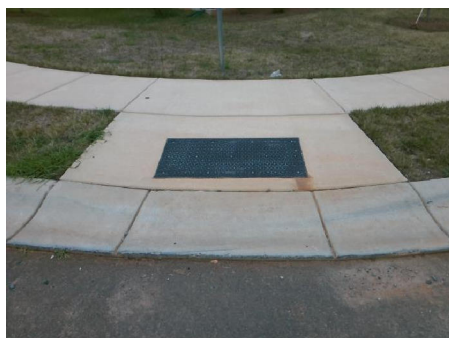
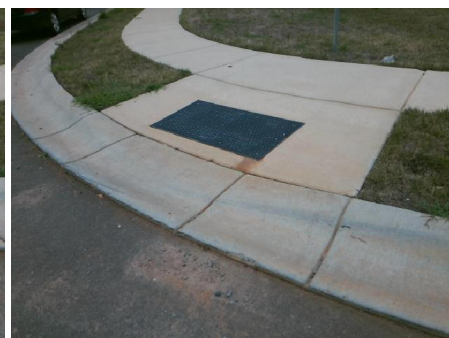
Compliance	Description	Data	Compliance	Description	Data
N/A	Ramp Length (in)	46.5	No	Ramp Slope (%)	10.5
Yes	Ramp Width (in)	48.0	Yes	Ramp XSlope (%)	1.8
N/A	Flare Type LT	N/A	N/A	Flare Type RT	N/A
N/A	Flare Slope LT (%)	N/A	N/A	Flare Slope RT (%)	N/A
N/A	Flare Traversable LT?	N/A	N/A	Flare Traversable RT?	N/A
N/A	Landing Length (in)	N/A	N/A	DWS Provided?	N/A
N/A	Landing Width (in)	N/A	N/A	DWS Contrast?	N/A
N/A	Landing Slope (%)	N/A	N/A	DWS Length (in)	N/A
N/A	Landing X Slope (%)	N/A	N/A	DWS Full Width?	N/A
N/A	Landing Curb? (Y/N)	N/A	N/A	DWS Offset (in)	N/A
N/A	Shared Landing?	N/A			
N/A	Gutter Ponding?	N/A	N/A	Gutter Slope (%)	N/A
N/A	Gutter Lip Ht (in)	1.5	N/A	Gutter X Slope (%)	N/A
N/A	Painted X Walk1?	No	N/A	Painted X Walk2?	No
	X Walk 1 Direction	To SW		X Walk 2 Direction	To SE
N/A	X Walk 1 Width (in)	N/A	N/A	X Walk 2 Width (in)	N/A
	X Walk 1 Slope (%)	1.7		X Walk 2 Slope (%)	1.2
	X Walk 1 X Slope (%)	2.8		X Walk 2 X Slope (%)	0.7

N/A	Ramp inside XWalk1?	N/A	N/A	Ramp inside XWalk2?	N/A
	Road Slope (%)	0.9	N/A	Clear Space?	N/A
	Road X Slope (%)	0.1	N/A	Clear Space to XWalk (in)	N/A
N/A	Any Obstructions?	N/A	N/A	Storm Grate/Utility Hazard?	N/A
	Obstruction Type			Storm Grate/Utility Type	
		N/A			N/A
		Yes		Surface Condition? (G/P)	Good

**Remove & Replace Curb Ramp With Two New Directional Ramps or Equivalent.**

**Not Found, R304.2.2**
