Access Compliance Report

Public Rights-of-Way

(Curb Ramps)

Intersection ID: 31553	Main Street: CALDWELL_RD	Cross Street: CALDWELL_RIDGE_PY	Location: S
ADA ID: 116EBF4EA8C4	Ramp Type: BlendTrans1	Initial Pass/Fail: Fail	Overall Compliance: No
Severity Score: 8.75			
Codes/Mitigation Info/Possible Solution		Field Measurements/Component Compliance

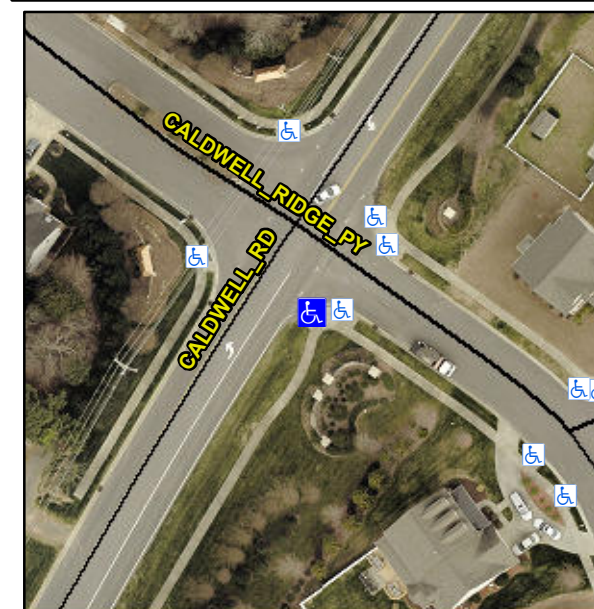
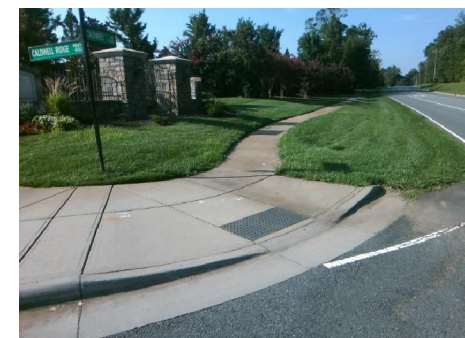
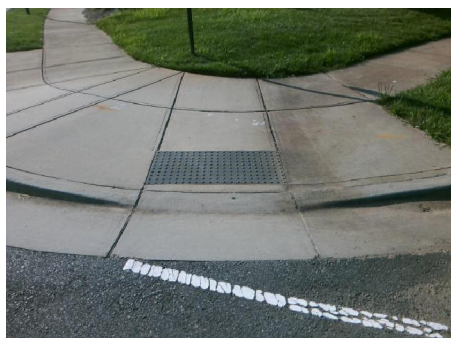
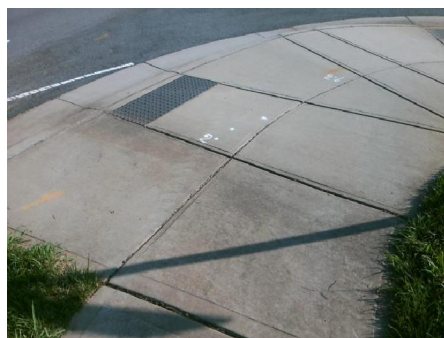
Not Found, R304.5.1

Compliance	Description	Data	Compliance	Description	Data
N/A	Ramp Length (in)	71.0	Yes	BlendTrans Slope (%)	4.3
No	Ramp Width (in)	47.0	Yes	BlendTrans XSlope (%)	1.5
N/A	Flare Type LT	N/A	N/A	Flare Type RT	N/A
N/A	Flare Slope LT (%)	N/A	N/A	Flare Slope RT (%)	N/A
N/A	Flare Traversable LT?	N/A	N/A	Flare Traversable RT?	N/A
N/A	Landing Length (in)	N/A	N/A	DWS Provided?	N/A
N/A	Landing Width (in)	N/A	N/A	DWS Contrast?	N/A
N/A	Landing Slope (%)	N/A	N/A	DWS Length (in)	N/A
N/A	Landing X Slope (%)	N/A	N/A	DWS Full Width?	N/A
N/A	Landing Curb? (Y/N)	N/A	N/A	DWS Offset (in)	N/A
N/A	Shared Landing?	N/A			
N/A	Gutter Ponding?	N/A	N/A	Gutter Slope (%)	N/A
N/A	Gutter Lip Ht (in)	N/A	N/A	Gutter X Slope (%)	N/A
N/A	Painted X Walk1?	No	N/A	Painted X Walk2?	N/A
	X Walk 1 Direction	To NW		X Walk 2 Direction	N/A
	X Walk 1 Width (in)	N/A		X Walk 2 Width (in)	N/A
	X Walk 1 Slope (%)	2.8		X Walk 2 Slope (%)	N/A
	X Walk 1 X Slope (%)	1.0		X Walk 2 X Slope (%)	N/A

N/A	Ramp inside XWalk1?	N/A	N/A	Ramp inside XWalk2?	N/A
	Road Slope (%)	1.0		Clear Space?	N/A
	Road X Slope (%)	2.8	N/A	Clear Space to XWalk (in)	N/A
N/A	Any Obstructions?	N/A	N/A	Storm Grate/Utility Hazard?	N/A
	Obstruction Type			Storm Grate/Utility Type	
		N/A			N/A
			Yes	Surface Condition? (G/P)	Good
			No	Curb Slope (%)	11.6

Remove & Replace Curb Ramp With Two New Directional Ramps or Equivalent.
