Access Compliance Report

Public Rights-of-Way

(Curb Ramps)

Intersection ID: 11845	Main Street: DUNWOODY_DR	Cross Street: STRANGFORD_AV	Location: W
ADA ID: 1175E79D1635	Ramp Type: BlendTrans1	Initial Pass/Fail: Fail	Overall Compliance: No
Severity Score: 10			
Codes/Mitigation Info/Possible Solution		Field Measurements/Component Compliance

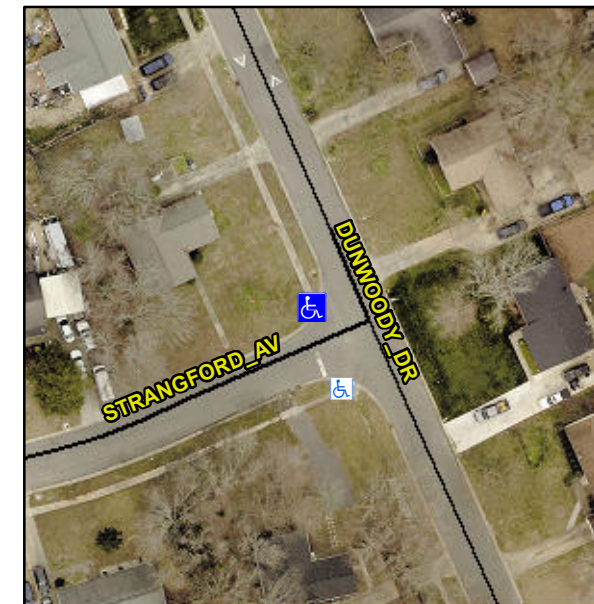
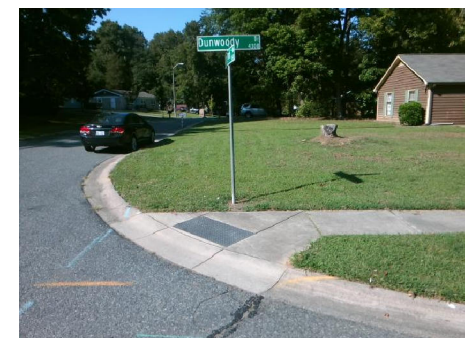
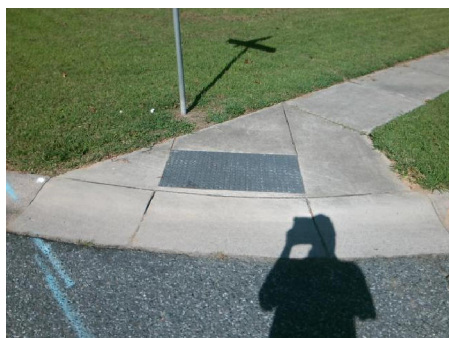
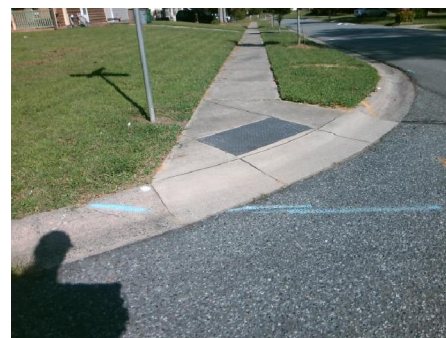
Not Found, R304.5.1, R304.5.3

Compliance	Description	Data	Compliance	Description	Data
N/A	Ramp Length (in)	36.5	Yes	BlendTrans Slope (%)	3.5
No	Ramp Width (in)	46.5	No	BlendTrans XSlope (%)	3.4
N/A	Flare Type LT	N/A	N/A	Flare Type RT	N/A
N/A	Flare Slope LT (%)	N/A	N/A	Flare Slope RT (%)	N/A
N/A	Flare Traversable LT?	N/A	N/A	Flare Traversable RT?	N/A
N/A	Landing Length (in)	N/A	N/A	DWS Provided?	N/A
N/A	Landing Width (in)	N/A	N/A	DWS Contrast?	N/A
N/A	Landing Slope (%)	N/A	N/A	DWS Length (in)	N/A
N/A	Landing X Slope (%)	N/A	N/A	DWS Full Width?	N/A
N/A	Landing Curb? (Y/N)	N/A	N/A	DWS Offset (in)	N/A
N/A	Shared Landing?	N/A			
N/A	Gutter Ponding?	N/A	N/A	Gutter Slope (%)	N/A
N/A	Gutter Lip Ht (in)	N/A	N/A	Gutter X Slope (%)	N/A
N/A	Painted X Walk1?	No	N/A	Painted X Walk2?	N/A
	X Walk 1 Direction	To SE		X Walk 2 Direction	N/A
	X Walk 1 Width (in)	N/A		X Walk 2 Width (in)	N/A
	X Walk 1 Slope (%)	2.6		X Walk 2 Slope (%)	N/A
	X Walk 1 X Slope (%)	1.7		X Walk 2 X Slope (%)	N/A

N/A	Ramp inside XWalk1?	N/A	N/A	Ramp inside XWalk2?	N/A
	Road Slope (%)	1.7		Clear Space?	N/A
	Road X Slope (%)	2.6	N/A	Clear Space to XWalk (in)	N/A
N/A	Any Obstructions?	N/A	N/A	Storm Grate/Utility Hazard?	N/A
	Obstruction Type			Storm Grate/Utility Type	
		N/A			N/A
			Yes	Surface Condition? (G/P)	Good
			No	Curb Slope (%)	11.3

Possible Solutions:

Remove & Replace Curb Ramp With Two New Directional Ramps or Equivalent.
