Access Compliance Report Public Rights-of-Way (Curb Ramps)

Intersection ID: 18299 Main Street: CHAPLIN_LN **Cross Street: LYTTLETON_DR** Location: NW **Overall Compliance: No** ADA ID: 11792B41D657 Ramp Type: Perp Initial Pass/Fail: Fail Severity Score: 46.25

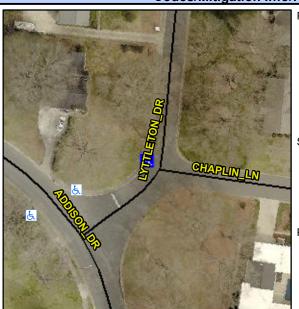
Field Measurements/Component Compliance							
Comp	liance Description	Data	Comp	liance Description	Data		
N/A	Ramp Length (in)	48.0	No	Ramp Slope (%)	10.4		
No	Ramp Width (in)	43.0	No	Ramp XSlope (%)	7.6		
N/A	Flare Type LT	N/A	N/A	Flare Type RT	N/A		
N/A	Flare Slope LT (%)	N/A	N/A	Flare Slope RT (%)	N/A		
N/A	Flare Traversable LT?	N/A	N/A	Flare Traversable RT?	N/A		
N/A	Landing Length (in)	N/A	N/A	DWS Provided?	N/A		
N/A	Landing Width (in)	N/A	N/A	DWS Contrast?	N/A		
N/A	Landing Slope (%)	N/A	N/A	DWS Length (in)	N/A		
N/A	Landing X Slope (%)	N/A	N/A	DWS Full Width?	N/A		
N/A	Landing Curb? (Y/N)	N/A	N/A	DWS Offset (in)	N/A		
N/A	Shared Landing?	N/A					
N/A	Gutter Ponding?	N/A	N/A	Gutter Slope (%)	N/A		
N/A	Gutter Lip Ht (in)	N/A	N/A	Gutter X Slope (%)	N/A		
N/A	Painted X Walk1?	No	N/A	Painted X Walk2?	N/A		
	X Walk 1 Direction	To SE		X Walk 2 Direction	N/A		
N/A	X Walk 1 Width (in)	N/A	N/A	X Walk 2 Width (in)	N/A

X Walk 1 Slope (%)	9.1		X Walk 2 Slope (%)	N/A		
	X Walk 1 X Slope (%)	6.2		X Walk 2 X Slope (%)	N/A		
N/A	Ramp inside XWalk1?	N/A	N/A	Ramp inside XWalk2?	N/A		
	Road Slope (%)	N/A	N/A	Clear Space?	N/A		
	Road X Slope (%)	N/A	N/A	Clear Space to XWalk (in)	N/A		
N/A	Any Obstructions?	N/A	N/A	Storm Grate/Utility Hazard?	N/A		
	Obstruction Type			Storm Grate/Utility Type			
		N/A			N/A		
			Yes	Surface Condition? (G/P)	Good

Possible Solutions:	2
Remove & Replace Entire Ramp.	ı
	ı
	ı
	I
	I
	I
Surveyor Notes:	I
N/A	I
	ı
	ا
	!
PROW/ADA:	
Not Found, R304.5.1, R304.2.2,	
R304.5.3	ı
1	,
