## Access Compliance Report Public Rights-of-Way (Curb Ramps)

Intersection ID: 10030162Main Street: LATHAM\_PLCross Street: N/ALocation:SWADA ID: 118092E0518FRamp Type: BlendTrans1Initial Pass/Fail: PassOverall Compliance: NoSeverity Score:15

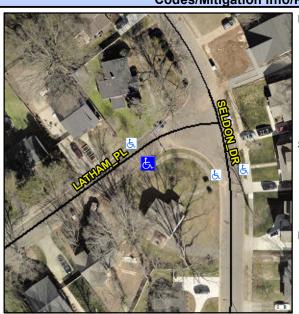
VEGETATION OVERGROWTH, NO RT SW

Compliance Description Data Compliance Description Data					
N/A	Ramp Length (in)	47.0	Yes	BlendTrans Slope (%)	4.2
Yes	Ramp Width (in)	48.0	Yes	BlendTrans XSlope (%)	0.4
N/A	Flare Type LT	Sloped	N/A	Flare Type RT	Sloped
N/A	Flare Slope LT (%)	3.5	N/A	Flare Slope RT (%)	1.9
N/A	Flare Traversable LT?	No	N/A	Flare Traversable RT?	No
Yes	Landing Length (in)	58.0	Yes	DWS Provided?	Yes
Yes	Landing Width (in)	48.0	Yes	DWS Contrast?	Yes
No	Landing Slope (%)	4.1	Yes	DWS Length (in)	24.5
Yes	Landing X Slope (%)	0.2	Yes	DWS Full Width?	Yes
N/A	Landing Curb? (Y/N)	No	Yes	DWS Offset (in)	0.0
N/A	Shared Landing?	No			
No	Gutter Ponding?	Yes	Yes	Gutter Slope (%)	1.7
No	Gutter Lip Ht (in)	1.5	Yes	Gutter X Slope (%)	0.6
N/A	Painted X Walk1?	No	N/A	Painted X Walk2?	N/A
	X Walk 1 Direction	To NW		X Walk 2 Direction	N/A
	X Walk 1 Width (in)	N/A		X Walk 2 Width (in)	N/A
	X Walk 1 Slope (%)	0.0		X Walk 2 Slope (%)	N/A
	X Walk 1 X Slope (%)	0.2		X Walk 2 X Slope (%)	N/A

N/A	Ramp inside XWalk1?	N/A	N/A	Ramp inside XWalk2?	N/A
	Road Slope (%)	0.2		Clear Space?	Yes
	Road X Slope (%)	0.0	N/A	Clear Space to XWalk (in)	N/A
Yes	Any Obstructions?	No	Yes	Storm Grate/Utility Hazard?	No
	Obstruction Type			Storm Grate/Utility Type	
		N/A			N/A
			Yes	Surface Condition? (G/P)	Good
			No	Curb Slope (%)	16.2

Remove & Replace Curb Ramp With Two New Directional Ramps or Equivalent.
