Access Compliance Report

Public Rights-of-Way

(Curb Ramps)

Intersection ID: 16267	Main Street: BEAM_RD	Cross Street: YORKMONT_RD	Location: W
ADA ID: 11866A85180F	Ramp Type: BlendTrans2	Initial Pass/Fail: Fail	Overall Compliance: No
Codes/Mitigation Info/Possible Solution		Field Measurements/Component Compliance	
Severity Score: 16.25

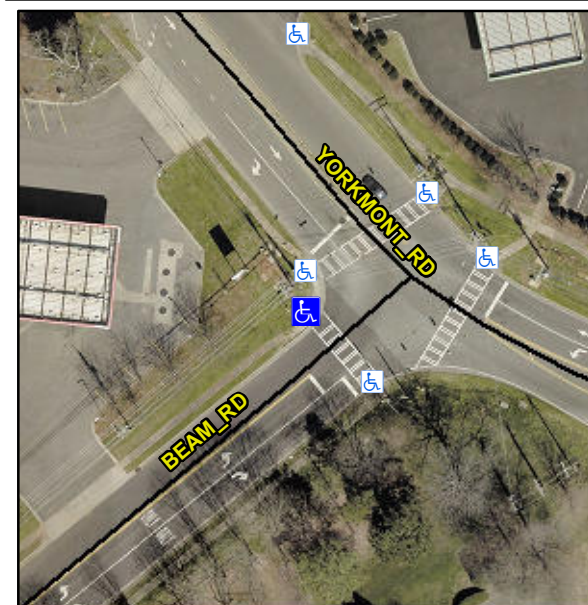
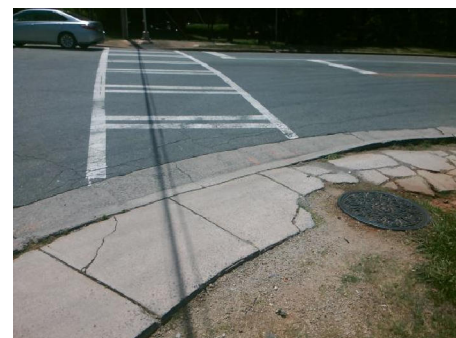
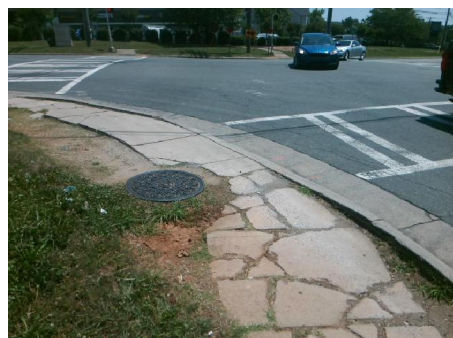
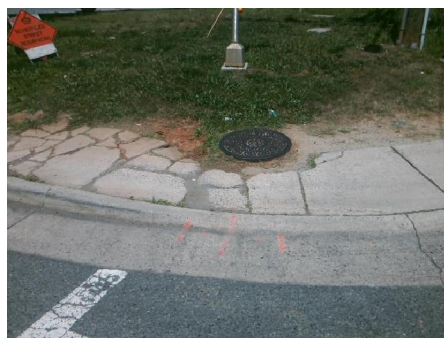
SURFACE DAMAGED

Not Found, R302.7

Compliance	Description	Data	Compliance	Description	Data
N/A	Ramp Length (in)	50.0	Yes	BlendTrans Slope (%)	2.2
Yes	Ramp Width (in)	53.0	Yes	BlendTrans XSlope (%)	3.7
N/A	Flare Type LT	N/A	N/A	Flare Type RT	N/A
N/A	Flare Slope LT (%)	N/A	N/A	Flare Slope RT (%)	N/A
N/A	Flare Traversable LT?	N/A	N/A	Flare Traversable RT?	N/A
N/A	Landing Length (in)	N/A	N/A	DWS Provided?	N/A
N/A	Landing Width (in)	N/A	N/A	DWS Contrast?	N/A
N/A	Landing Slope (%)	N/A	N/A	DWS Length (in)	N/A
N/A	Landing X Slope (%)	N/A	N/A	DWS Full Width?	N/A
N/A	Landing Curb? (Y/N)	N/A	N/A	DWS Offset (in)	N/A
N/A	Shared Landing?	N/A			
N/A	Gutter Ponding?	N/A	N/A	Gutter Slope (%)	N/A
N/A	Gutter Lip Ht (in)	N/A	N/A	Gutter X Slope (%)	N/A
N/A	Painted X Walk1?	Yes	N/A	Painted X Walk2?	N/A
	X Walk 1 Direction	To SE		X Walk 2 Direction	N/A
	X Walk 1 Width (in)	108.0		X Walk 2 Width (in)	N/A
	X Walk 1 Slope (%)	6.2		X Walk 2 Slope (%)	N/A
	X Walk 1 X Slope (%)	4.4		X Walk 2 X Slope (%)	N/A

N/A	Ramp inside XWalk1?	Yes	N/A	Ramp inside XWalk2?	N/A
	Road Slope (%)	4.4		Clear Space?	N/A
	Road X Slope (%)	6.2	N/A	Clear Space to XWalk (in)	N/A
N/A	Any Obstructions?	N/A	N/A	Storm Grate/Utility Hazard?	N/A
	Obstruction Type			Storm Grate/Utility Type	
		N/A			N/A
			No	Surface Condition? (G/P)	Poor
			No	Curb Slope (%)	10.0

Remove & Replace Curb Ramp With Two New Directional Ramps or Equivalent.
