Access Compliance Report

Public Rights-of-Way

(Curb Ramps)

Intersection ID: 14003	Main Street: MT_VERNON_AV	Cross Street: MYRTLE_AV	Location: NE
ADA ID: 118C926F84AE	Ramp Type: PerpDiag	Initial Pass/Fail: Fail	Overall Compliance: No
			Severity Score: 21.25

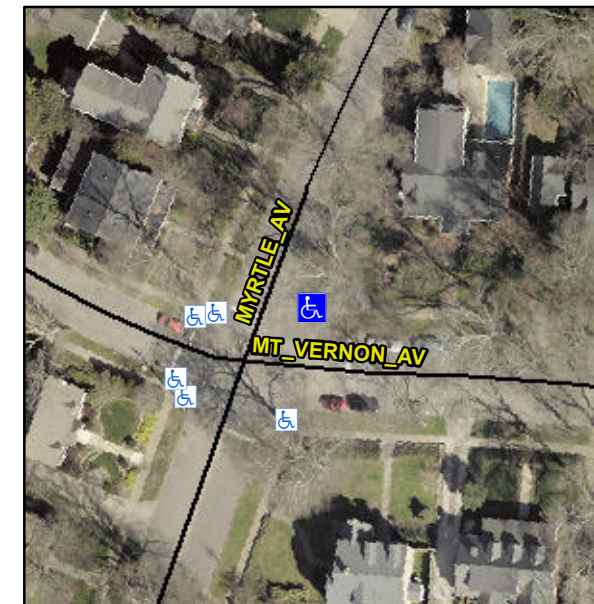
Compliance	Description	Data	Compliance	Description	Data
N/A	Ramp Length (in)	72.0	Yes	Ramp Slope (%)	5.5
No	Ramp Width (in)	47.0	No	Ramp XSlope (%)	6.2
N/A	Flare Type LT	N/A	N/A	Flare Type RT	N/A
N/A	Flare Slope LT (%)	N/A	N/A	Flare Slope RT (%)	N/A
N/A	Flare Traversable LT?	N/A	N/A	Flare Traversable RT?	N/A
N/A	Landing Length (in)	N/A	N/A	DWS Provided?	N/A
N/A	Landing Width (in)	N/A	N/A	DWS Contrast?	N/A
N/A	Landing Slope (%)	N/A	N/A	DWS Length (in)	N/A
N/A	Landing X Slope (%)	N/A	N/A	DWS Full Width?	N/A
N/A	Landing Curb? (Y/N)	N/A	N/A	DWS Offset (in)	N/A
N/A	Shared Landing?	N/A			
N/A	Gutter Ponding?	N/A	N/A	Gutter Slope (%)	N/A
N/A	Gutter Lip Ht (in)	1.0	N/A	Gutter X Slope (%)	N/A
N/A	Painted X Walk1?	No	N/A	Painted X Walk2?	No
	X Walk 1 Direction	To NW		X Walk 2 Direction	To SW
N/A	X Walk 1 Width (in)	N/A	N/A	X Walk 2 Width (in)	N/A
	X Walk 1 Slope (%)	2.6		X Walk 2 Slope (%)	8.4
	X Walk 1 X Slope (%)	5.4		X Walk 2 X Slope (%)	0.4

N/A	Ramp inside XWalk1?	N/A	N/A	Ramp inside XWalk2?	N/A
	Road Slope (%)	3.2	N/A	Clear Space?	N/A
	Road X Slope (%)	8.1	N/A	Clear Space to XWalk (in)	N/A
N/A	Any Obstructions?	N/A	N/A	Storm Grate/Utility Hazard?	N/A
	Obstruction Type			Storm Grate/Utility Type	
		N/A			N/A
			Yes	Surface Condition? (G/P)	Good

Remove & Replace Curb Ramp With Two New Directional Ramps or Equivalent.

R304.5.1, R304.5.3
