Access Compliance Report Public Rights-of-Way (Curb Ramps)

Intersection ID: 30324 Main Street: FOREST STREAM CT **Cross Street: HIDDEN FOREST DR** Location: NW Ramp Type: PerpDiag Initial Pass/Fail: Pass **Overall Compliance: No Severity Score:** 12.5 **ADA ID: 119EA20CE292**

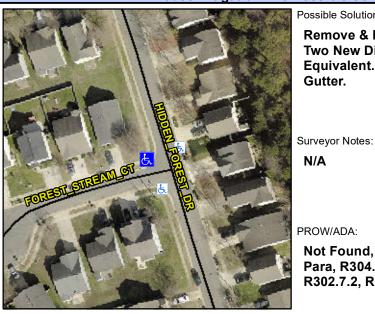
| Compliance Description Data | | Com | pliance Description | Data | |
|---|---|---|---|---|---|
| No | Landing Slope (%) | 2.8 | Yes | DWS Length (in) | 25.5 |
| No | Landing X Slope (%) | 2.6 | Yes | DWS Full Width? | Yes |
| No | Gutter Ponding? | Yes | No | Gutter Slope (%) | 7.5 |
| No | Gutter Lip Ht (in) | 0.5 | Yes | Gutter X Slope (%) | 0.6 |

Possible Solutions: Remove & Replace Curb Ramp With Two New Directional Ramps or Equivalent. Remove & Replace Gutter.

Not Found, R304.2.2-Perp, R304.3.2-Para, R304.5.3, R305.2, R302.7, R302.7.2, R304.5.4
