# Access Compliance Report

## Public Rights-of-Way

### (Curb Ramps)

Intersection ID: 54402	Main Street: SPRINGMAN_LN	Cross Street: LOMA_LINDA_LN	Location: SE
ADA ID: 11A56E60E1DA	Ramp Type: BlendTrans1	Initial Pass/Fail: Fail	Overall Compliance: No
Severity Score: 25			
Codes/Mitigation Info/Possible Solution		Field Measurements/Component Compliance

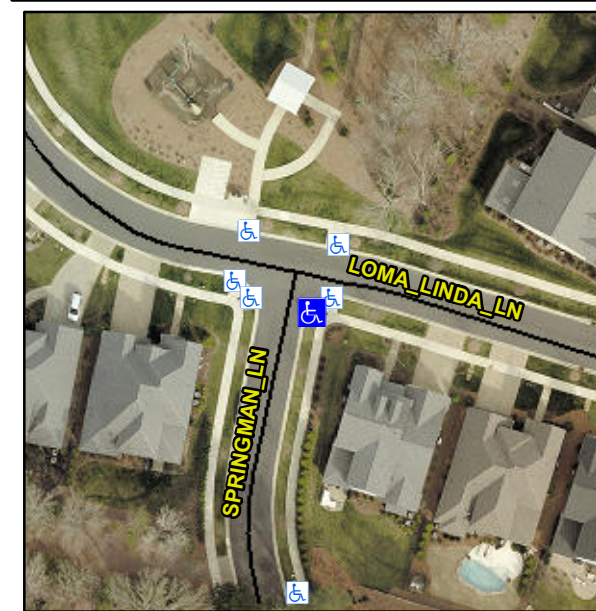
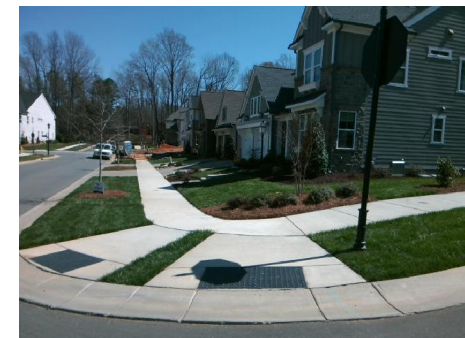
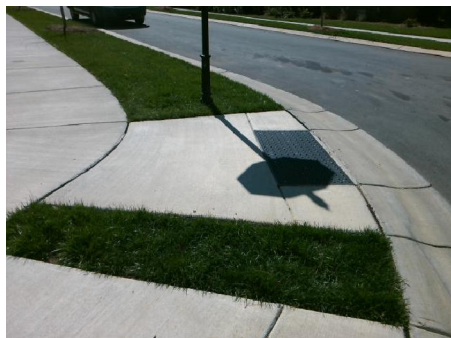
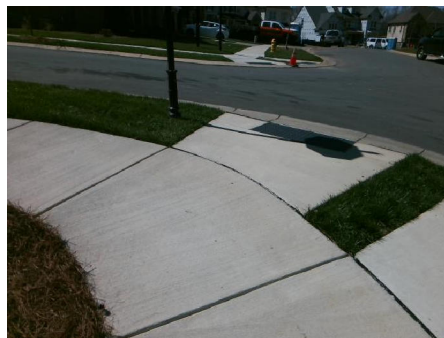
**Not Found, R304.5.3**

Compliance	Description	Data	Compliance	Description	Data
N/A	Ramp Length (in)	76.0	Yes	BlendTrans Slope (%)	4.6
Yes	Ramp Width (in)	48.0	No	BlendTrans XSlope (%)	7.2
N/A	Flare Type LT	N/A	N/A	Flare Type RT	N/A
N/A	Flare Slope LT (%)	N/A	N/A	Flare Slope RT (%)	N/A
N/A	Flare Traversable LT?	N/A	N/A	Flare Traversable RT?	N/A
N/A	Landing Length (in)	N/A	N/A	DWS Provided?	N/A
N/A	Landing Width (in)	N/A	N/A	DWS Contrast?	N/A
N/A	Landing Slope (%)	N/A	N/A	DWS Length (in)	N/A
N/A	Landing X Slope (%)	N/A	N/A	DWS Full Width?	N/A
N/A	Landing Curb? (Y/N)	N/A	N/A	DWS Offset (in)	N/A
N/A	Shared Landing?	N/A			
N/A	Gutter Ponding?	N/A	N/A	Gutter Slope (%)	N/A
N/A	Gutter Lip Ht (in)	N/A	N/A	Gutter X Slope (%)	N/A
N/A	Painted X Walk1?	No	N/A	Painted X Walk2?	N/A
	X Walk 1 Direction	To W		X Walk 2 Direction	N/A
	X Walk 1 Width (in)	N/A		X Walk 2 Width (in)	N/A
	X Walk 1 Slope (%)	5.3		X Walk 2 Slope (%)	N/A
	X Walk 1 X Slope (%)	4.7		X Walk 2 X Slope (%)	N/A

N/A	Ramp inside XWalk1?	N/A	N/A	Ramp inside XWalk2?	N/A
	Road Slope (%)	4.7		Clear Space?	N/A
	Road X Slope (%)	5.3	N/A	Clear Space to XWalk (in)	N/A
N/A	Any Obstructions?	N/A	N/A	Storm Grate/Utility Hazard?	N/A
	Obstruction Type			Storm Grate/Utility Type	
		N/A			N/A
			Yes	Surface Condition? (G/P)	Good
			No	Curb Slope (%)	13.8

**Remove & Replace Curb Ramp With Two New Directional Ramps or Equivalent.**
