# Access Compliance Report

## Public Rights-of-Way

### (Curb Ramps)

| Intersection ID: 5500 | Main Street: NORTHWOODS_FOREST_DR | Cross Street: SUGAR_HOLLOW_DR | Location: | N |

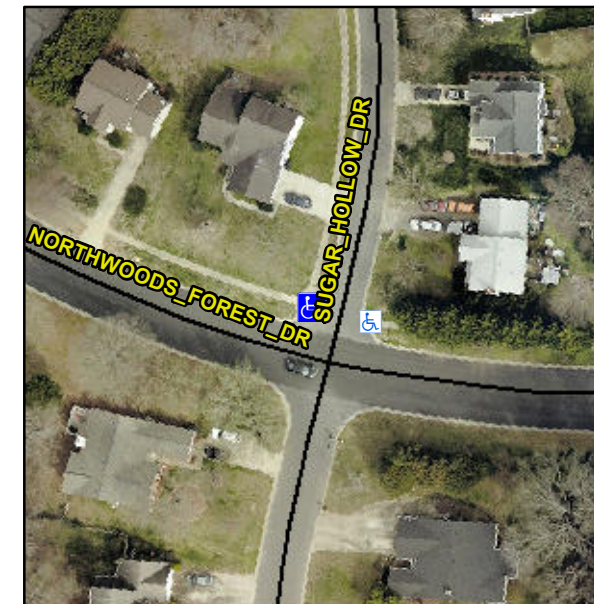
| ADA ID: 11AA0131CFBE | Ramp Type: Perp | Initial Pass/Fail: Fail | Overall Compliance: No | Severity Score: 12.5 |

**Not Found, R304.2.2**

| Compliance | Description | Data | Compliance | Description | Data |
|---|---|---|---|---|---|
| N/A | Ramp Length (in) | 105.0 | No | Ramp Slope (%) | 8.4 |

**Remove & Replace Entire Ramp.**

Total Cost: \$ 1850.00

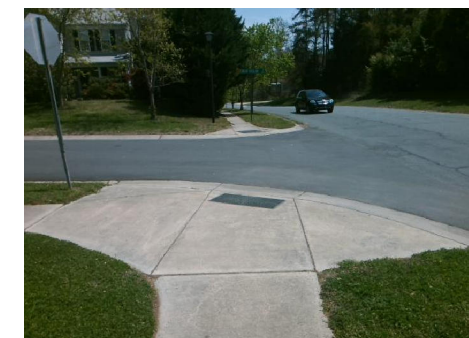
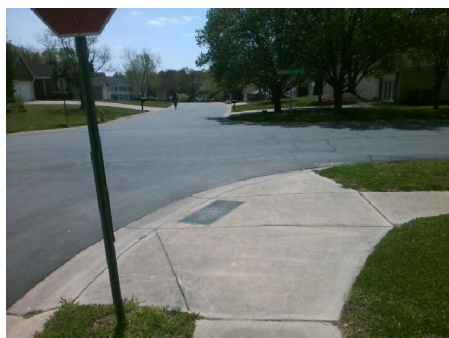
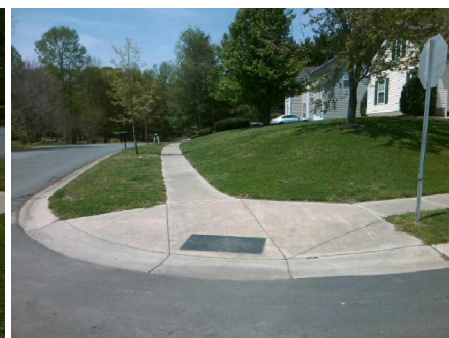
| Compliance | Description | Data | Compliance | Description | Data |
|---|---|---|---|---|---|
| N/A | Painted X Walk1? | No | N/A | Painted X Walk2? | N/A |
| | | | Yes | Surface Condition? (G/P) | Good |
