Access Compliance Report

Public Rights-of-Way

(Curb Ramps)

Intersection ID: 8413	Main Street: CROMER_ST	Cross Street: GOSSETT_AV	Location: NW
ADA ID: 11AFA7280167	Ramp Type: Perp	Initial Pass/Fail: Fail	Overall Compliance: No
Codes/Mitigation Info/Possible Solution		Field Measurements/Component Compliance

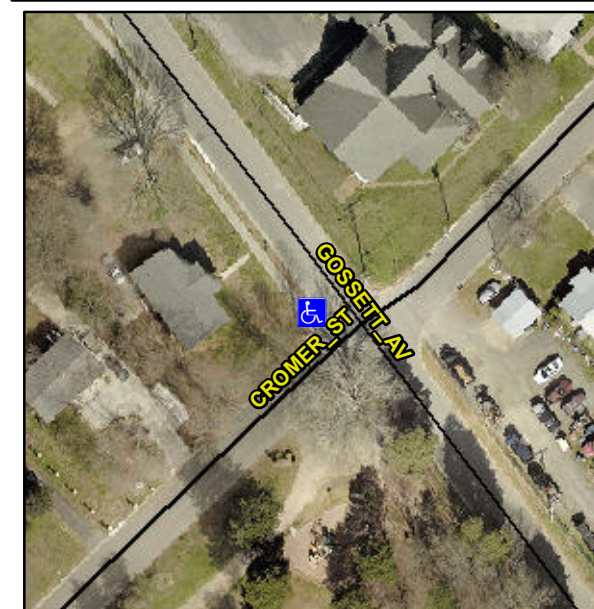
Not Found, R304.5.1, R304.5.3

Compliance	Description	Data	Compliance	Description	Data
N/A	Ramp Length (in)	26.0	Yes	Ramp Slope (%)	5.9
No	Ramp Width (in)	47.0	No	Ramp XSlope (%)	2.2
N/A	Flare Type LT	N/A	N/A	Flare Type RT	N/A
N/A	Flare Slope LT (%)	N/A	N/A	Flare Slope RT (%)	N/A
N/A	Flare Traversable LT?	N/A	N/A	Flare Traversable RT?	N/A
N/A	Landing Length (in)	N/A	N/A	DWS Provided?	N/A
N/A	Landing Width (in)	N/A	N/A	DWS Contrast?	N/A
N/A	Landing Slope (%)	N/A	N/A	DWS Length (in)	N/A
N/A	Landing X Slope (%)	N/A	N/A	DWS Full Width?	N/A
N/A	Landing Curb? (Y/N)	N/A	N/A	DWS Offset (in)	N/A
N/A	Shared Landing?	N/A			
N/A	Gutter Ponding?	N/A	N/A	Gutter Slope (%)	N/A
N/A	Gutter Lip Ht (in)	N/A	N/A	Gutter X Slope (%)	N/A
N/A	Painted X Walk1?	No	N/A	Painted X Walk2?	N/A
	X Walk 1 Direction	To S		X Walk 2 Direction	N/A
N/A	X Walk 1 Width (in)	N/A	N/A	X Walk 2 Width (in)	N/A
	X Walk 1 Slope (%)	0.5		X Walk 2 Slope (%)	N/A
	X Walk 1 X Slope (%)	1.4		X Walk 2 X Slope (%)	N/A

N/A	Ramp inside XWalk1?	N/A	N/A	Ramp inside XWalk2?	N/A
	Road Slope (%)	1.4	N/A	Clear Space?	N/A
	Road X Slope (%)	0.5	N/A	Clear Space to XWalk (in)	N/A
N/A	Any Obstructions?	N/A	N/A	Storm Grate/Utility Hazard?	N/A
	Obstruction Type			Storm Grate/Utility Type	
			N/A		N/A
			Yes	Surface Condition? (G/P)	Good

Possible Solutions:

Remove & Replace Entire Ramp.

Total Cost: \$ 1850.00
