Access Compliance Report

Public Rights-of-Way

(Curb Ramps)

Intersection ID: 10025333	Main Street: E_6TH_ST	Cross Street: N/A	Location: S
ADA ID: 11B29FCB9B19	Ramp Type: Perp	Initial Pass/Fail: Pass	Overall Compliance: No
Severity Score: 0			
Codes/Mitigation Info/Possible Solution		Field Measurements/Component Compliance

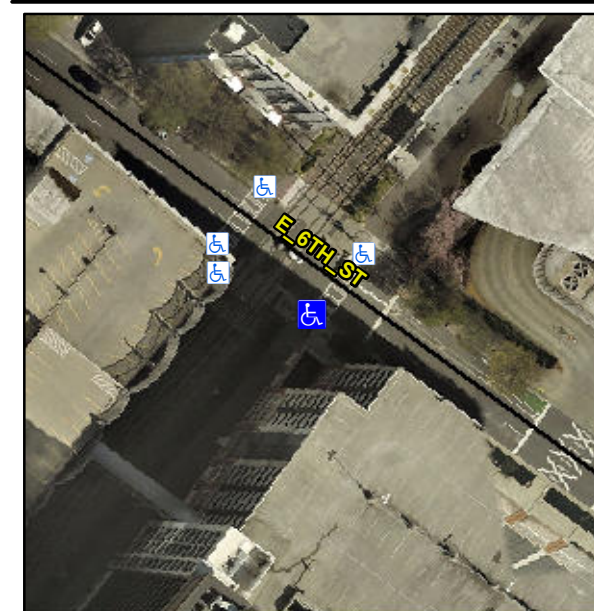
Not Found, R304.2.2-Perp, R304.3.2-Para

Compliance	Description	Data	Compliance	Description	Data
N/A	Ramp Length (in)	38.0	Yes	Ramp Slope (%)	5.5
Yes	Ramp Width (in)	48.0	Yes	Ramp XSlope (%)	0.3
N/A	Flare Type LT	Sloped	N/A	Flare Type RT	N/A
N/A	Flare Slope LT (%)	2.5	Yes	Flare Slope RT (%)	3.4
N/A	Flare Traversable LT?	Yes	N/A	Flare Traversable RT?	Yes
Yes	Landing Length (in)	48.0	Yes	DWS Provided?	Yes
Yes	Landing Width (in)	48.0	Yes	DWS Contrast?	Yes
No	Landing Slope (%)	4.5	Yes	DWS Length (in)	24.0
Yes	Landing X Slope (%)	0.4	Yes	DWS Full Width?	Yes
N/A	Landing Curb? (Y/N)	No	Yes	DWS Offset (in)	1.5
N/A	Shared Landing?	No			
Yes	Gutter Ponding?	No	Yes	Gutter Slope (%)	2.4
Yes	Gutter Lip Ht (in)	0.0	Yes	Gutter X Slope (%)	1.3
N/A	Painted X Walk1?	Yes	N/A	Painted X Walk2?	N/A
	X Walk 1 Direction	To NE		X Walk 2 Direction	N/A
N/A	X Walk 1 Width (in)	109.0	N/A	X Walk 2 Width (in)	N/A
	X Walk 1 Slope (%)	1.8		X Walk 2 Slope (%)	N/A
	X Walk 1 X Slope (%)	0.5		X Walk 2 X Slope (%)	N/A

Yes	Ramp inside XWalk1?	Yes	N/A	Ramp inside XWalk2?	N/A
	Road Slope (%)	N/A	N/A	Clear Space?	Yes
	Road X Slope (%)	N/A	N/A	Clear Space to XWalk (in)	N/A
Yes	Any Obstructions?	No	Yes	Storm Grate/Utility Hazard?	No
	Obstruction Type			Storm Grate/Utility Type	
		N/A			N/A
			Yes	Surface Condition? (G/P)	Good

Remove & Replace Entire Ramp.
