# Access Compliance Report

## Public Rights-of-Way

### (Curb Ramps)

Intersection ID: 10038457	Main Street: SOUTHERN_PINE_BV	Cross Street: N/A	Location: W
ADA ID: 11BCA1A142E1	Ramp Type: PerpDiag	Initial Pass/Fail: Fail	Overall Compliance: No
		Severity Score: 25

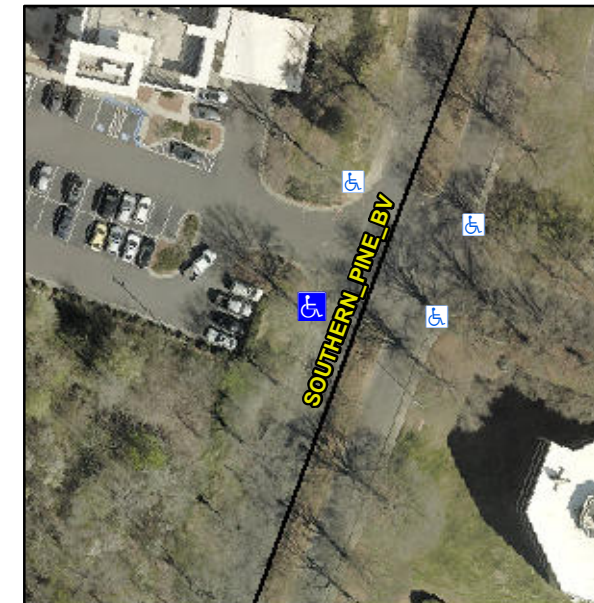
Compliance	Description	Data	Compliance	Description	Data
N/A	Ramp Length (in)	48.0	Yes	Ramp Slope (%)	5.3
Yes	Ramp Width (in)	48.0	No	Ramp XSlope (%)	7.1
N/A	Flare Type LT	N/A	N/A	Flare Type RT	N/A
N/A	Flare Slope LT (%)	N/A	N/A	Flare Slope RT (%)	N/A
N/A	Flare Traversable LT?	N/A	N/A	Flare Traversable RT?	N/A
N/A	Landing Length (in)	N/A	N/A	DWS Provided?	N/A
N/A	Landing Width (in)	N/A	N/A	DWS Contrast?	N/A
N/A	Landing Slope (%)	N/A	N/A	DWS Length (in)	N/A
N/A	Landing X Slope (%)	N/A	N/A	DWS Full Width?	N/A
N/A	Landing Curb? (Y/N)	N/A	N/A	DWS Offset (in)	N/A
N/A	Shared Landing?	N/A			
N/A	Gutter Ponding?	N/A	N/A	Gutter Slope (%)	N/A
N/A	Gutter Lip Ht (in)	N/A	N/A	Gutter X Slope (%)	N/A
N/A	Painted X Walk1?	No	N/A	Painted X Walk2?	No
	X Walk 1 Direction	To SE		X Walk 2 Direction	To NE
N/A	X Walk 1 Width (in)	N/A	N/A	X Walk 2 Width (in)	N/A
	X Walk 1 Slope (%)	3.8		X Walk 2 Slope (%)	5.5
	X Walk 1 X Slope (%)	4.3		X Walk 2 X Slope (%)	7.0

N/A	Ramp inside XWalk1?	N/A	N/A	Ramp inside XWalk2?	N/A
	Road Slope (%)	1.0	N/A	Clear Space?	N/A
	Road X Slope (%)	4.5	N/A	Clear Space to XWalk (in)	N/A
N/A	Any Obstructions?	N/A	N/A	Storm Grate/Utility Hazard?	N/A
	Obstruction Type			Storm Grate/Utility Type	
		N/A			N/A
			Yes	Surface Condition? (G/P)	Good

**Remove & Replace Curb Ramp With Two New Directional Ramps or Equivalent.**

**R304.5.3**
