# Access Compliance Report

## Public Rights-of-Way

### (Curb Ramps)

| Intersection ID: 48855 | Main Street: NEELY_GLEN_DR | Cross Street: SLEDGE_RD | Location: S |

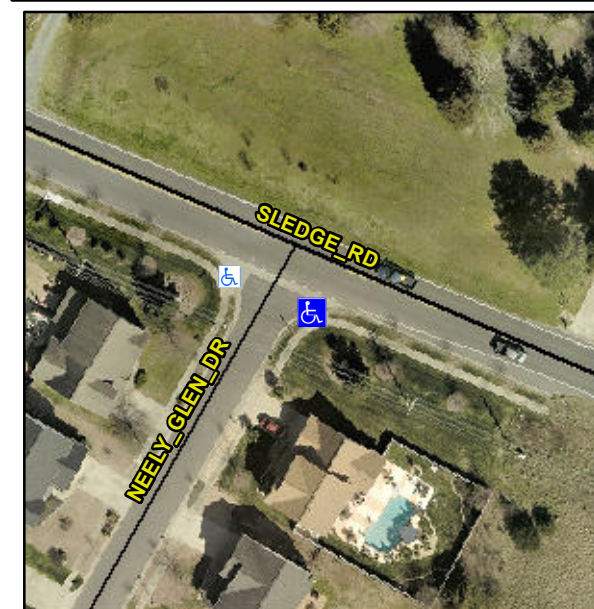
| ADA ID: 11BFC8198502 | Ramp Type: PerpDiag | Initial Pass/Fail: Fail | Overall Compliance: No |
| Severity Score: 10 | | | |

**R304.5.1, R304.5.3**

| Compliance | Description | Data | Compliance | Description | Data |
|---|---|---|---|---|---|
| N/A | Ramp Length (in) | 95.0 | Yes | Ramp Slope (%) | 5.3 |
| No | Ramp Width (in) | 42.0 | No | Ramp XSlope (%) | 4.1 |

**Remove & Replace Curb Ramp With Two New Directional Ramps or Equivalent.**

Total Cost: \$ 3200.00
