# Access Compliance Report

## Public Rights-of-Way

### (Curb Ramps)

Intersection ID: 11717	Main Street: E_15TH_ST	Cross Street: N_DAVIDSON_ST	Location: W
ADA ID: 11C2D91B530C	Ramp Type: PerpDiag	Initial Pass/Fail: Fail	Overall Compliance: No
		Severity Score: 8.75

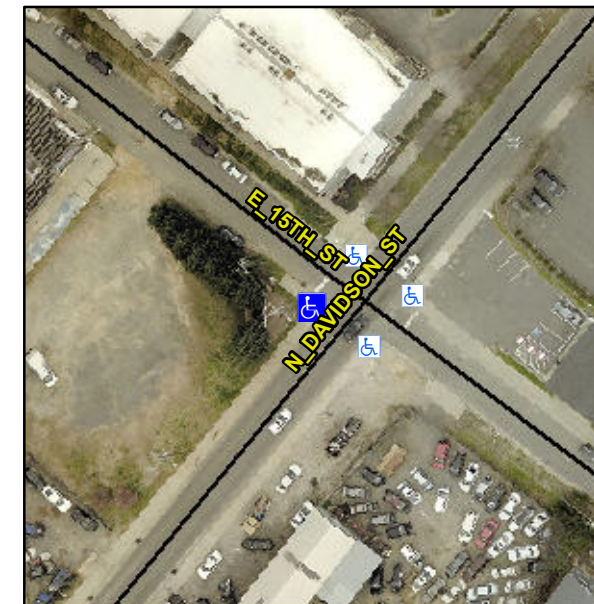
**Not Found, R304.5.1**

Compliance	Description	Data	Compliance	Description	Data
N/A	Ramp Length (in)	64.0	Yes	Ramp Slope (%)	6.3
No	Ramp Width (in)	47.5	Yes	Ramp XSlope (%)	1.8
N/A	Flare Type LT	N/A	N/A	Flare Type RT	N/A
N/A	Flare Slope LT (%)	N/A	N/A	Flare Slope RT (%)	N/A
N/A	Flare Traversable LT?	N/A	N/A	Flare Traversable RT?	N/A
N/A	Landing Length (in)	N/A	N/A	DWS Provided?	N/A
N/A	Landing Width (in)	N/A	N/A	DWS Contrast?	N/A
N/A	Landing Slope (%)	N/A	N/A	DWS Length (in)	N/A
N/A	Landing X Slope (%)	N/A	N/A	DWS Full Width?	N/A
N/A	Landing Curb? (Y/N)	N/A	N/A	DWS Offset (in)	N/A
N/A	Shared Landing?	N/A			
N/A	Gutter Ponding?	N/A	N/A	Gutter Slope (%)	N/A
N/A	Gutter Lip Ht (in)	0.5	N/A	Gutter X Slope (%)	N/A
N/A	Painted X Walk1?	No	N/A	Painted X Walk2?	No
	X Walk 1 Direction	To SE		X Walk 2 Direction	To NE
N/A	X Walk 1 Width (in)	N/A	N/A	X Walk 2 Width (in)	N/A
	X Walk 1 Slope (%)	3.0		X Walk 2 Slope (%)	0.7
	X Walk 1 X Slope (%)	0.7		X Walk 2 X Slope (%)	1.3

N/A	Ramp inside XWalk1?	N/A	N/A	Ramp inside XWalk2?	N/A
	Road Slope (%)	0.8	N/A	Clear Space?	N/A
	Road X Slope (%)	2.7	N/A	Clear Space to XWalk (in)	N/A
N/A	Any Obstructions?	N/A	N/A	Storm Grate/Utility Hazard?	N/A
	Obstruction Type			Storm Grate/Utility Type	
		N/A			N/A
			Yes	Surface Condition? (G/P)	Good

**Remove & Replace Curb Ramp With Two New Directional Ramps or Equivalent.**

Total Cost: \$ 3200.00
